## "ANALYSIS OF CLAY FILL USING X-RAY TECHNIQUE"

JAMES F. PHIPPS, P.E.<sup>1</sup>  
RONALD F. REED, P.E.<sup>2</sup>

### **Abstract**

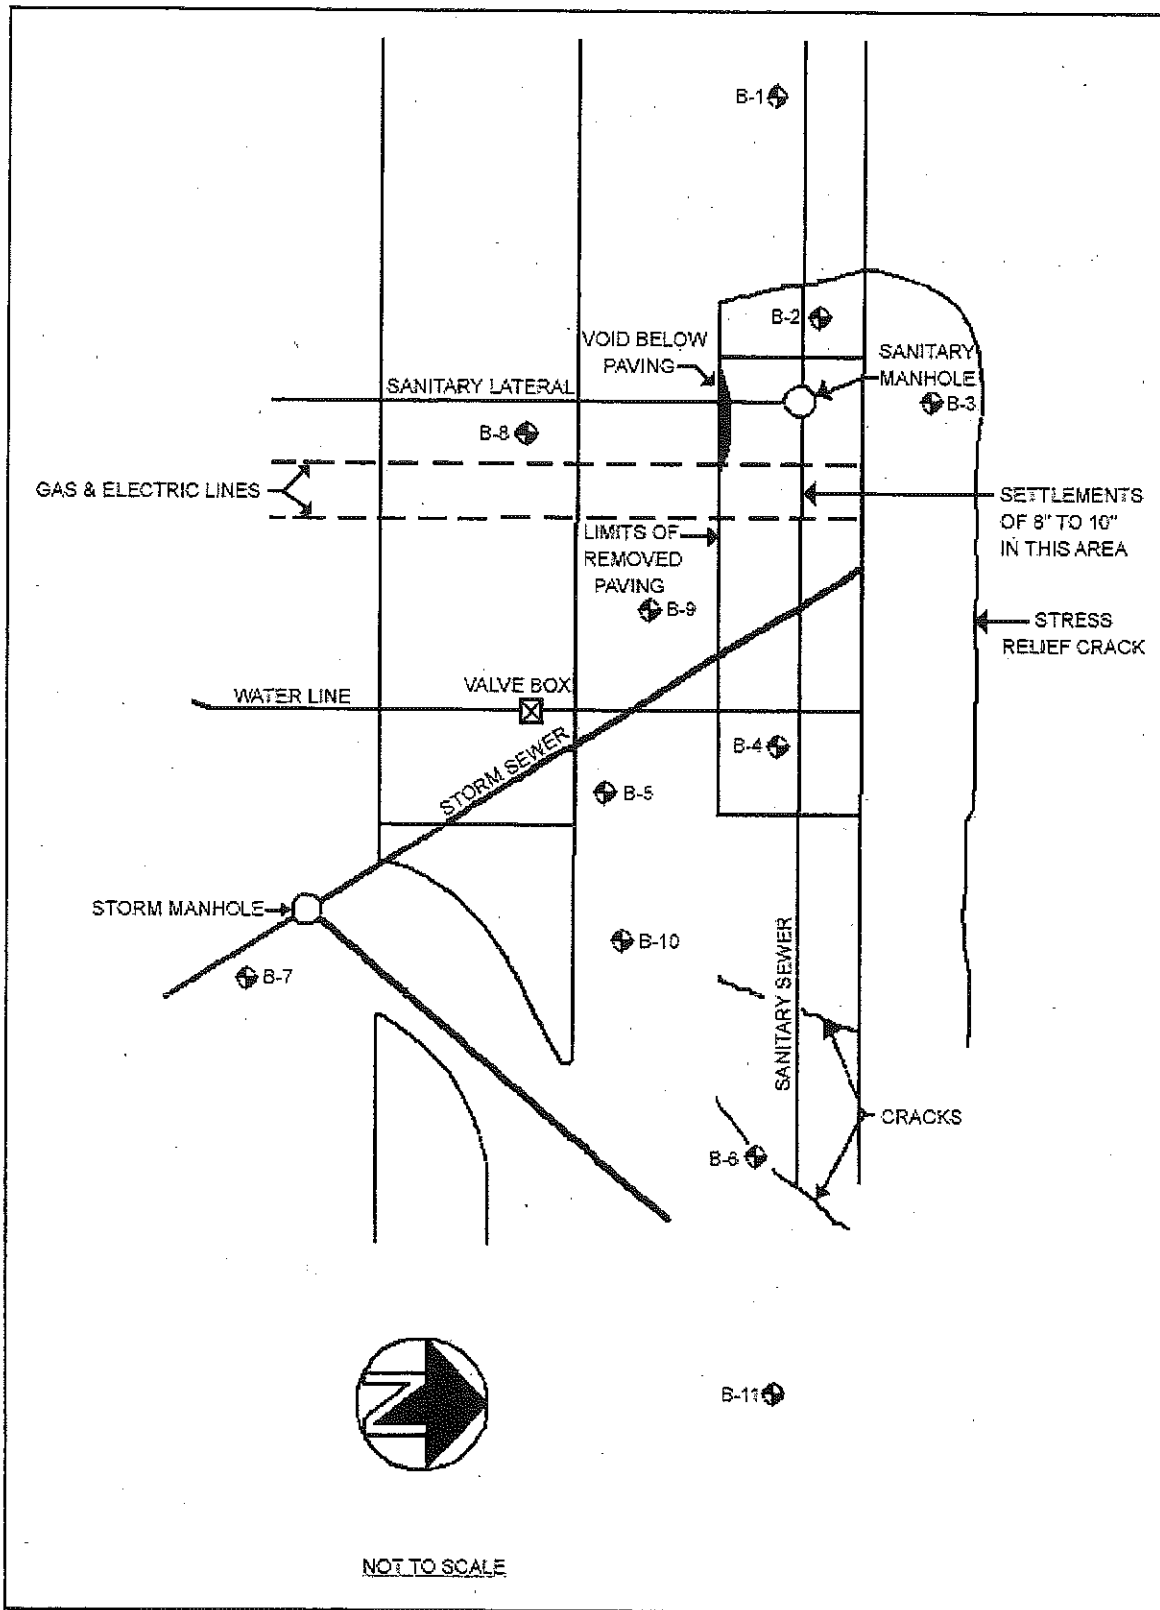
This section of paving was located over a conflux of underground utilities that included sanitary and storm sewer lines (Figure 1). The storm lines were placed 6 to 7 feet below finished grades, while the sanitary line was located 25 to 27 feet below the top of paving. The storm lines consisted of pre-cast, non-gasketed, concrete pipe that extended north from a detention pond just south of the road. The line under the failed area was capped at the edge of the paving to allow for future development. Sanitary improvements consisted of the main line, a manhole and a lateral line.

Figure 1: Plan of Borings for first and second rounds of soil sampling in August and October, 1999. Note location of underground utilities and distress.

When the detention pond was operating at normal level, water would back up into the storm pipe and under the roadway. The only section that exhibited severe settlement was that portion over the utility lines within the north, westbound lanes (Station 25+00).

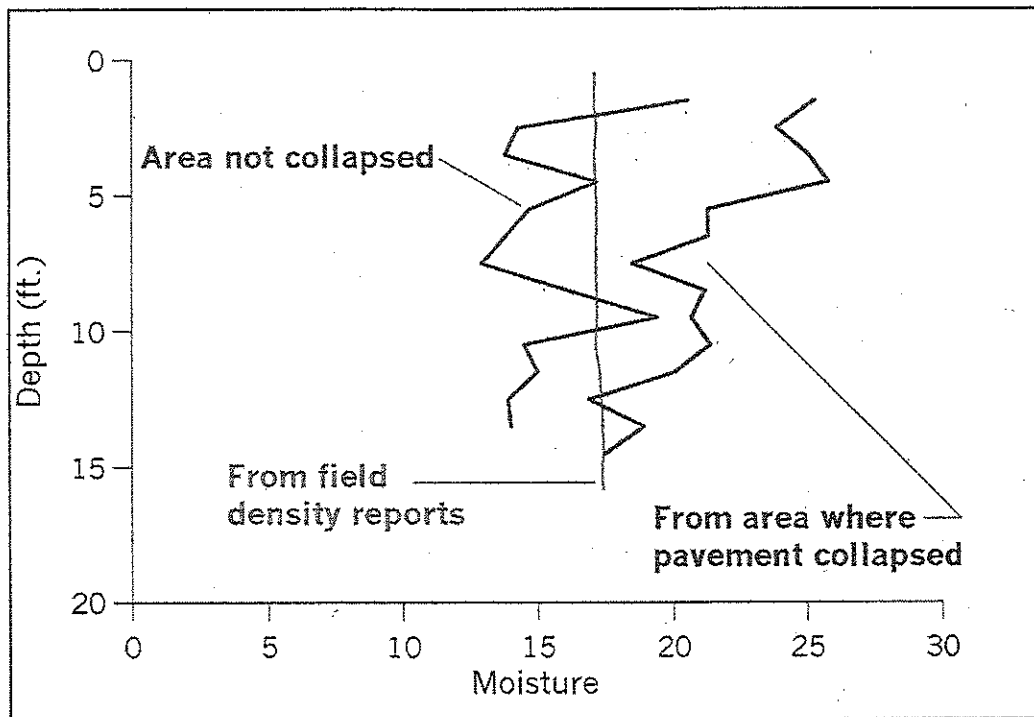
Figure 2 shows the relationship between soil moisture contents between collapsed and non-collapsed areas. For information purposes, in-place moisture measurements from field density reports are also presented. Soil moisture contents in non-collapsed areas are generally lower than from collapsed locations. This relationship was true for all borings drilled west and east of the distress at Station 25+00.

Figure 2: Comparison of soil moisture with depth between collapsed and non-collapsed areas. Results of in-place field density tests are shown for comparison.

Test results indicated fills along the sanitary line that were currently stable had soil moisture contents of 10 to 19 percent with corresponding pocket penetrometer readings of 4.5 tons per square foot (tsf) or higher. Areas that had exhibited collapse or settlement had moisture contents of 19 to 26 percent. Penetrometer values were generally below 2.5 tsf.

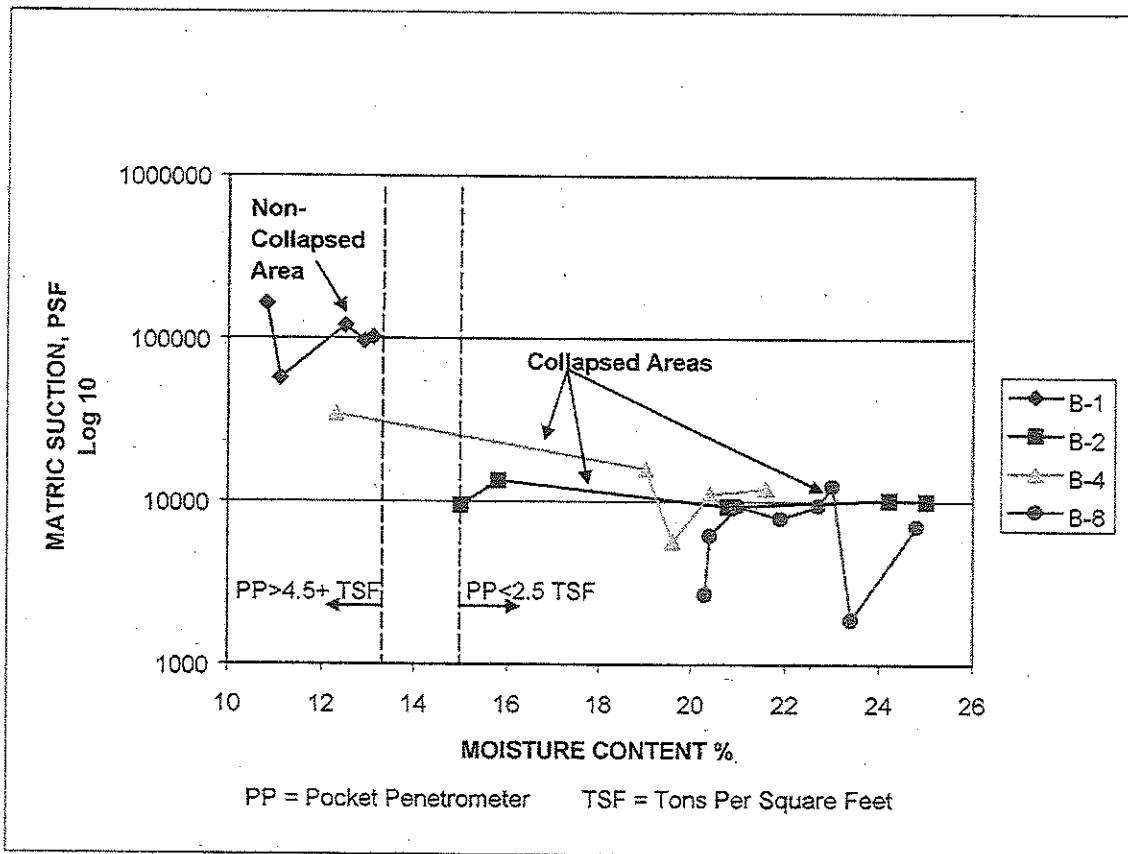
Figure 3 presents a comparison among pocket penetrometer readings, soil moisture content, and soil suction values from collapsed and non-collapsed locations. Note the relationship is the same as in Figure 2. Collapsed areas contain lower penetrometer readings that correspond to relatively higher moisture contents, while readings from non-collapsed areas are high. This indicates low soil moisture at these locations.

Figure 3: Relationship among matric suction, soil moisture and pocket penetrometer readings for samples taken from utility trench for collapsed and non-collapsed areas.

For dry soils, soil suction values varied considerably while, for fill materials with higher moisture contents, suction values were more uniform.

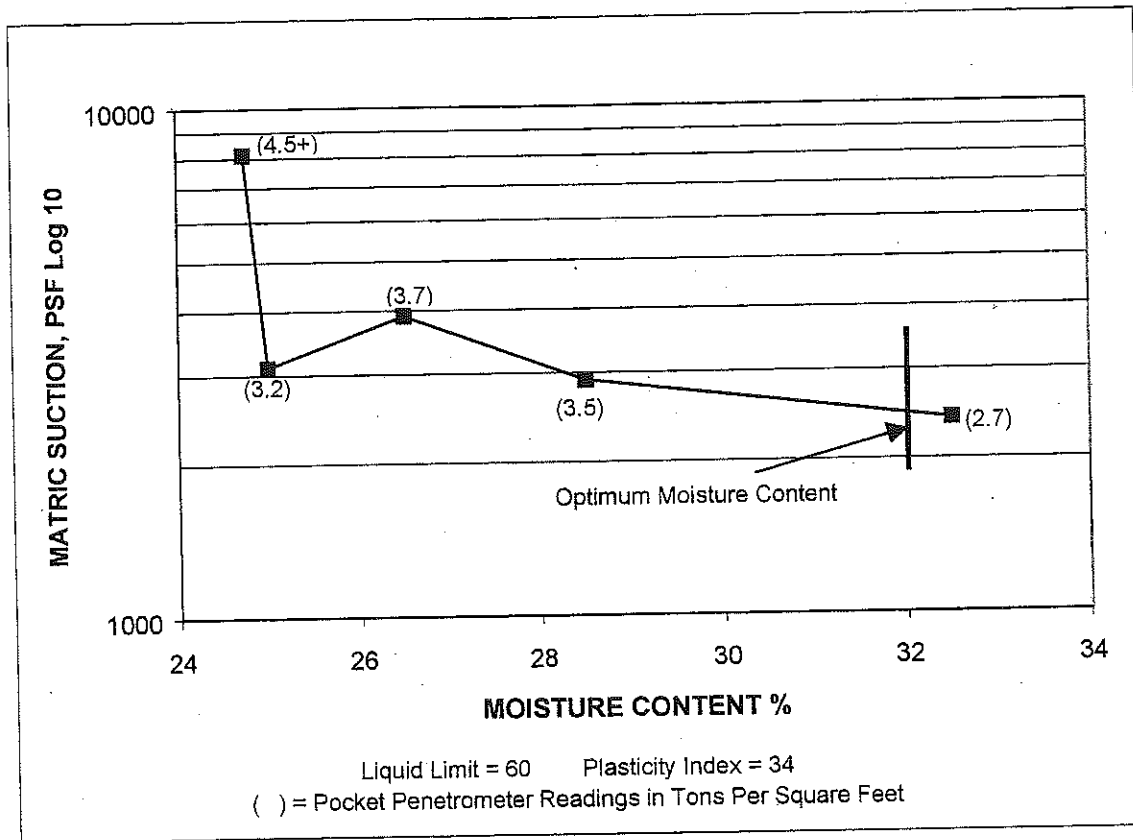
Figure 4 shows the relationship among soil moisture, density, and matric soil suction for a highly (CH) plastic clay. As seen, the tendency is for matric suction to decrease with an increase in soil moisture.

Figure 4: Relationship of matric suction and soil moisture for laboratory samples compacted in accordance with ASTM D-698. Pocket penetrometer readings are shown for comparison.

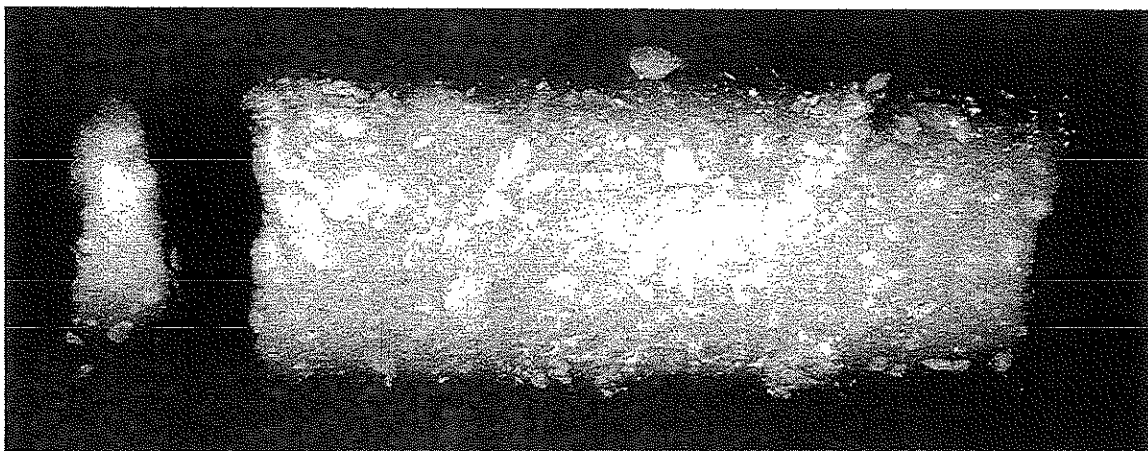
Considering the above discussion on the formation of clods in excavated soils, these x-rays indicated the fills used in the utility trenches were compacted below optimum moisture. This is evidenced by the large amounts of soil clods. Photograph 1 shows x-rays of a sample of fill from the utility trench.

Photograph 1: X-ray of sample from utility trench. Note amount of soil clods within sample.

In all samples, there were a number of clods that resulted in a soil structure with a relatively large void ratio. Additional x-rays were made on samples from a project in the same area that utilized similar soils for fill. These x-rays are presented in Photograph 2.

Based on the results of the investigation, it appears the on-site soils were compacted below optimum moisture. Clods that formed when these soils were excavated were not broken down during the compaction process. This resulted in an interlocked soil structure with relatively large voids between the clods.

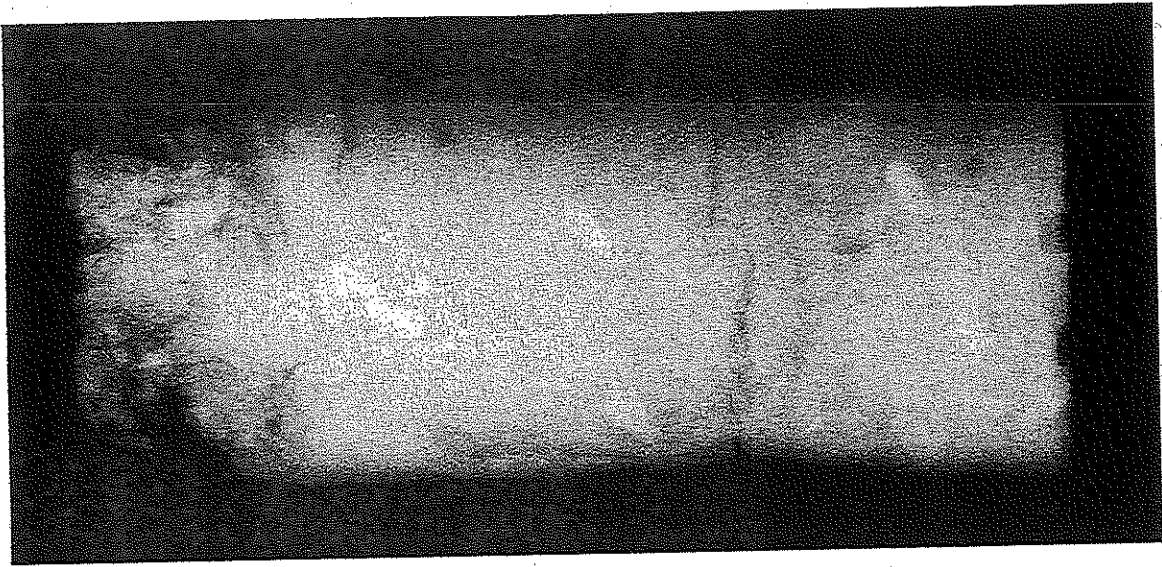
Photograph 2: X-ray of sandy clay fill placed above optimum moisture content. Note number of soil clods as compared to Photograph 1.

When compared with samples of soil placed above optimum moisture content, relatively few clods are seen. Comparisons between the x-rays of fill samples and undisturbed alluvial clay indicated that clods were absent in the natural soils.

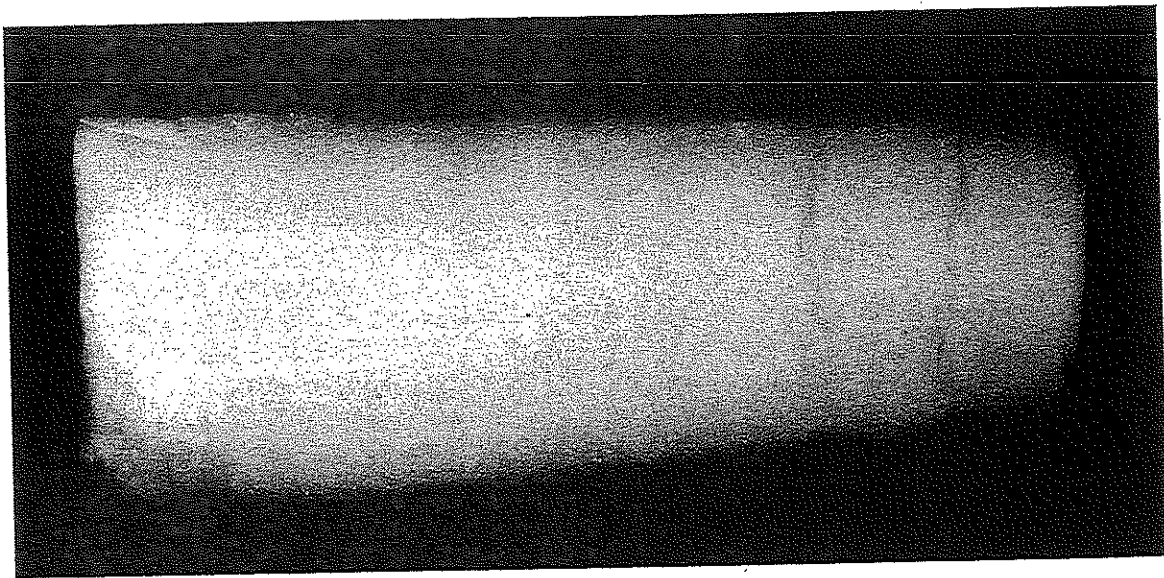
Photograph 3: X-ray of undisturbed alluvial clay. Note lack of soil clods as compared to Photographs 1 and 2.
