EXPERT OR LITIGATION “HIT-PERSON”?

Ronald F. Reed, P.E.¹
Member, ASCE
Reed Engineering Group, Ltd.

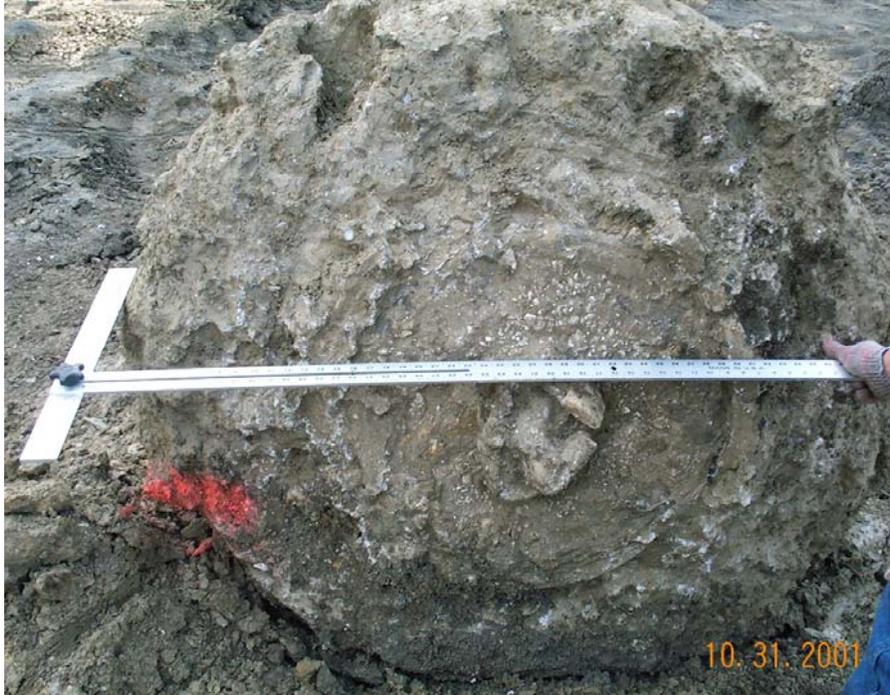
All three exhumed piers had similar shapes. The bottom of one of the three piers completely exhumed is shown in Photograph 1. By exhuming the piers, the bottom of the underream could also be inspected. It was noted by the poor quality of the concrete mold that the bottom had significant loose soil at the time the concrete was placed.

Photograph 1. Bottom of exhumed pier. Note how poorly the underream was cleaned of debris at time of concrete placement.

Based on the information in Table 2, and extensive experience in the area on other projects, it was believed that the cause of excessive settlement (in excess of approximately one inch) was associated with incomplete extension of the bell coupled with insufficient cleaning of the excavation of loose soil prior to placement of the concrete.

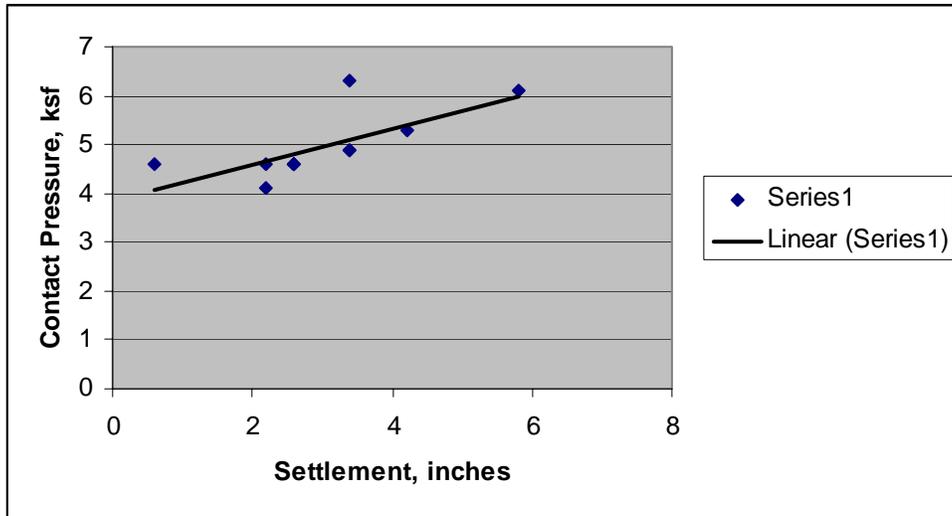
Based on the information shown in Table 2, a load versus settlement curve was developed and is provided in Figure 1. The data appeared to show a clear relationship between approximate contact pressure and settlement. Figure 1 was also considered to be very conservative because the “contact pressure” calculation was based on the projected area of the smaller bell. Clearly, because of loose soil remaining in the excavation at the time concrete was placed, the actual bearing surface was smaller than the projected area of the bell.

Figure 1. Contact pressure versus observed settlement.

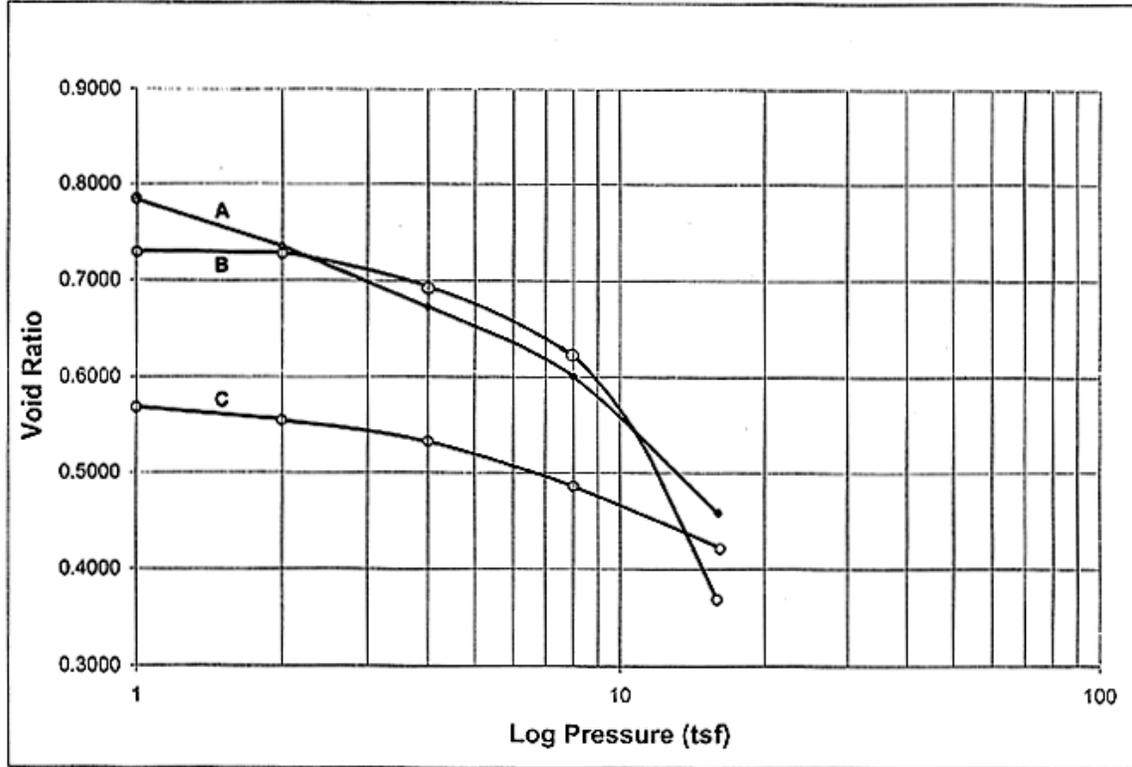
Figure 2. Consolidation tests

Curve “A” is a classic shape associated with a test performed on a severely disturbed sample (Schmertmann, 1953). For Curve “C”, the preconsolidation pressure was never determined because of termination of the test at 16 tons per square foot (tsf). Apparently not recognizing that consolidation Tests “A” and “C” were not valid, after extensive computer modeling, the consultant’s conclusion was that the original geotechnical investigation’s bearing pressure was in error. Clearly, if consolidation Test “B” was correct with an even higher preconsolidation pressure for Test “C”, then limited settlement at the design bearing should have occurred. Legal wrangling ensued.

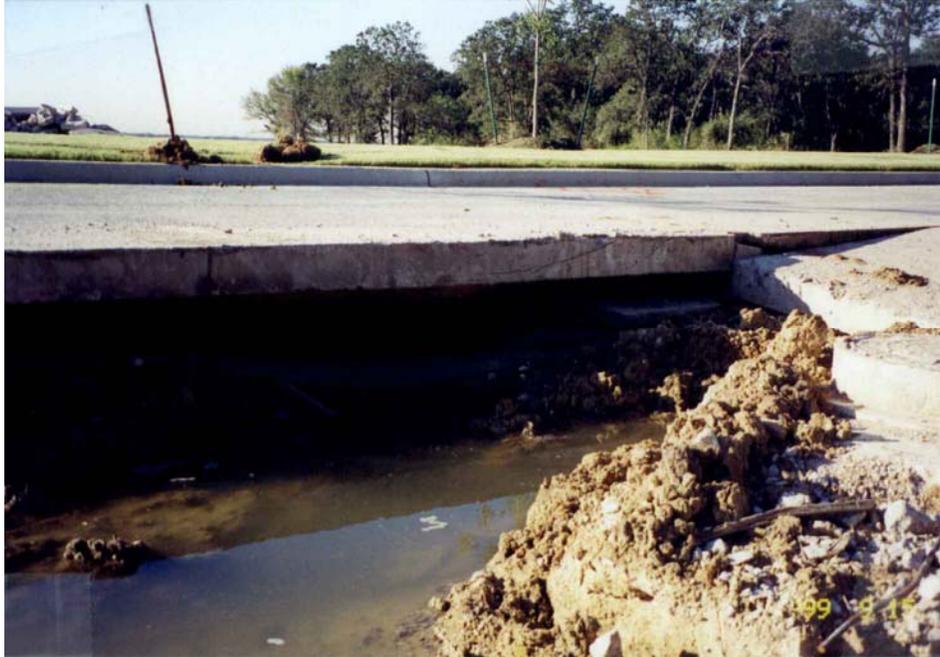
As seasonal rainfall progressed, water ponded within excavated areas which had initially settled, thus exacerbating saturation of the fill. The settlement extended below paving, resulting in gross pavement failure. An example of the magnitude of settlement is shown in Photograph 2.

Photograph 2. Example of degree of utility line excavation settlement.

Borings performed in the backfill in areas exhibiting settlement encountered very soft (pocket penetrometer values of 0 to 1.0 tsf), very moist clay. The dry unit of the fill varied from approximately 88 to 95 percent of ASTM D 698 density. Because the samples were obtained after settlement had occurred, the pre-settlement densities were estimated to be below 90 percent required density.
