LESSONS LEARNED FROM DISTRESS OF FOUNDATIONS ON EXPANSIVE CLAYS IN THE ACTIVE ZONE

Ronald F. Reed, P.E.¹, Kenneth E. Tand, P.E.², and Cumaraswamy Vipulanandan, Ph.D., P.E.³

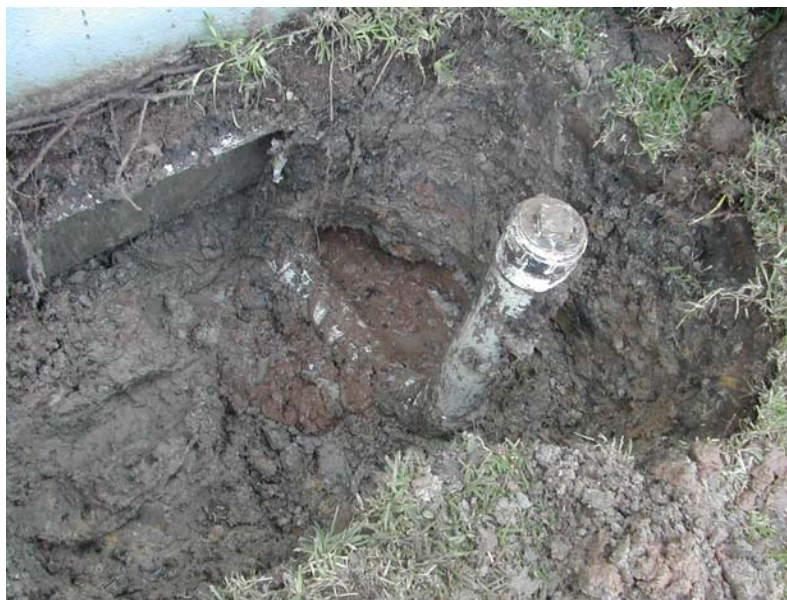
The areas where the largest amount of heave occurred were over the underground sewer line and close to the planter beds. However, camera surveys and leak detection tests did not find leaking sewer lines. The MEP engineer who designed the underground utilities specified that the underground sanitary sewer lines be bedded and encased in sand. The 'clean-out' for the lines was located at the west wall in the landscape area. As shown on Photo 1, a test pit in this area found water-bearing sand backfill at a depth of 1½ feet (0.5m). Since the clean-out pipe slopes down to the main line, water was flowing by gravity down the sand-filled trench to the main trunk line, where it went south and exited the building. Another test pit in the area where the main trunk line exited the building found wet sand backfill around the pipe.

Photo 1: Water Bearing Trench Backfill

The distress occurred due to a combination of errors. The geotechnical engineer-of-record failed to adequately address the high swell potential that existed at this site, and he under-estimated the depth of the active zone. Furthermore, the number of borings and the quantity of laboratory testing was inadequate to determine the expansive nature of the clay subsoils. The landscape architect did not understand the impact that water has on expansive clays, and the MEP engineer designed a pipeline for direct movement of water under the building.

The lesson learned is to only hire qualified professionals for the geotechnical study, and to prepare the plans and specifications. A "dollar saved" by the owner by bidding professional service can result in hundreds of thousands of dollars in damages, and much larger costs if litigation occurs.

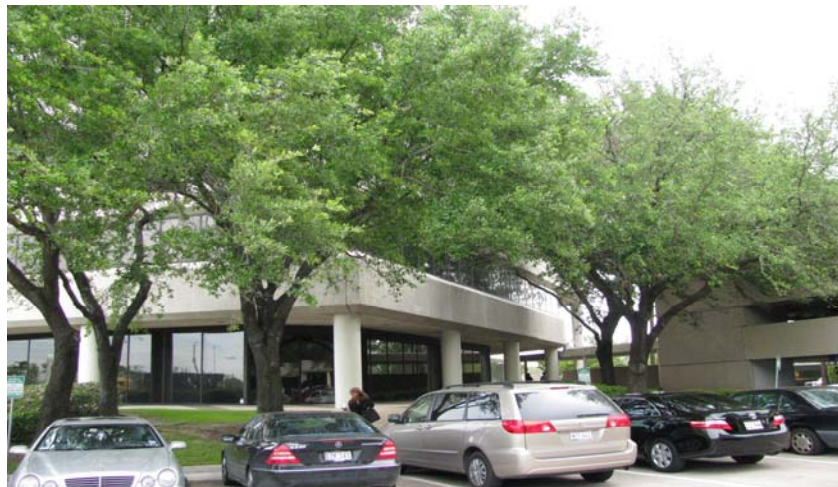
A water level survey found that 1 to 2½ inches (2.5 to 6.4cm) of settlement of the ground-supported slab occurred at the southwest corner of the building. Differential movement caused cracks in dry walls, sticking doors, gaps along the baseboards, and separations at the ceiling tiles. A water level survey was also performed on the 3rd floor, and 2½ inches (6.4cm) of settlement of the footing at the southwest corner was found, and the footing east of this location settled $\pm 1\frac{1}{2}$ inches (3.8cm).

As shown on Photo 2, there were 5 oak trees ranging from 20 to 30 inches (50 to 76 cm) in diameter close to the building where the settlement occurred. The building was elevated on a berm about 2 feet (0.6m) above the parking lot and driveways, and drainage was very good. The grass on the south side was sparse due to the lack of water, and what grass that remained was severely distressed.

Photo 2: Oak Trees at Perimeter of Building

The landscape architect clearly did not understand the fact that moisture loss due to trees would cause settlement of the foundation. The depth of the active zone due to moisture demand of trees can be much greater than the presently accepted “depth of seasonal moisture change” of 5 to 10 feet (1.5 to 3m) in Houston.

The trees were removed by the owner to stop any additional settlement. An 8-foot (2.4m) deep vertical moisture barrier was placed next to the building in the area where the trees were removed in an attempt to slow down and equalize the moisture content of the clays as they suck moisture to reach an equilibrium condition. The building is currently being monitored for potential rebound as the moisture content stabilizes over time.

The lesson learned is not to plant trees close to buildings on expansive clays unless a deep foundation system is used, and a structural slab is designed and constructed so that it does not deflect when the soil shrinks away. Also, trees can lower the moisture content to deep depths greatly magnifying the potential for heave if a building is constructed over the area where a tree or trees have been removed.

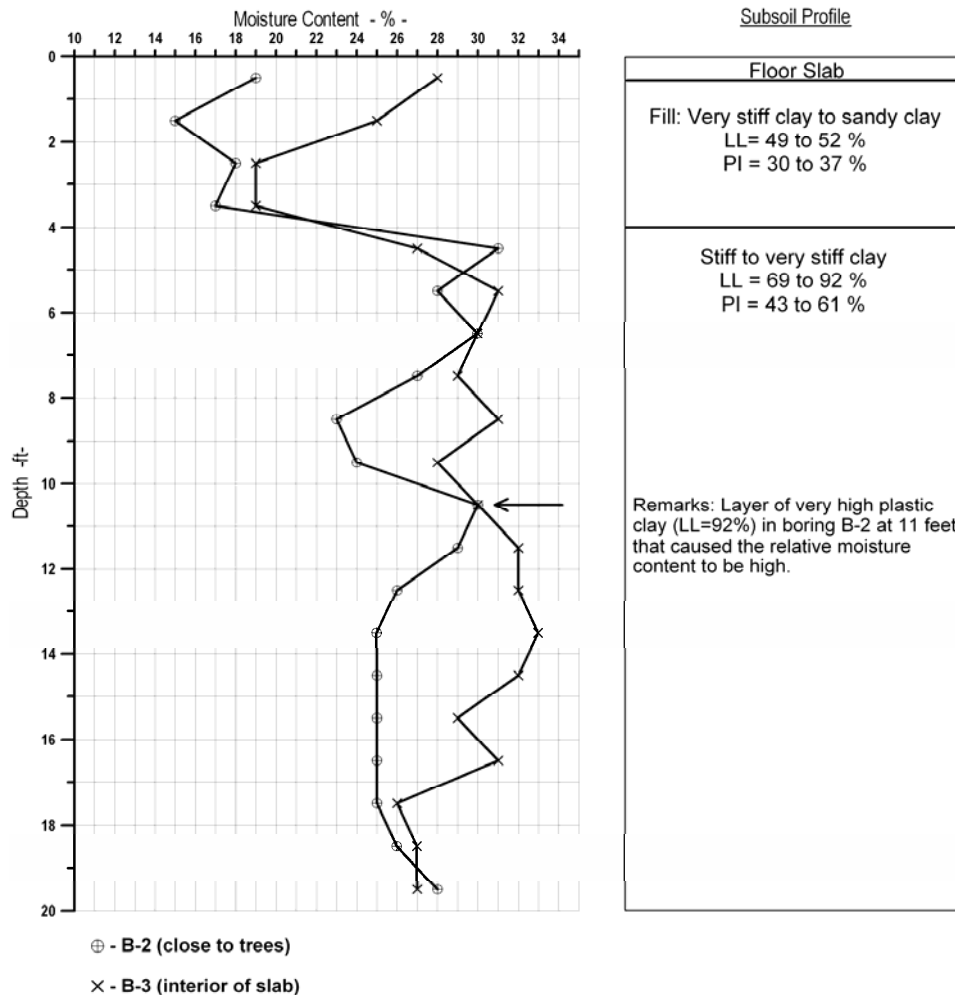
Figure 1 presents a plot of moisture content versus depth, and it indicates that the depth of the active zone is ± 18 feet (5.5m). The soil suction tests indicate constant suction occurs at a depth of ± 20 feet (6.1m). For comparison, the presently accepted depth of “seasonal moisture change” is 5 to 10 feet (1.5 to 3m) in Houston (O’Neill, 1980).

Figure 1: Profile of Moisture Content vs. Depth

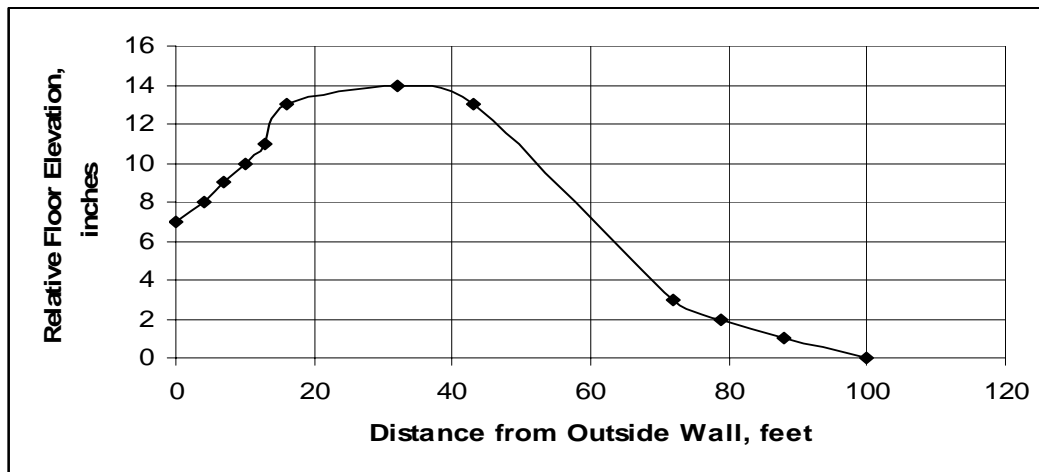
A relative differential elevation survey of the floor was performed in 2005. A copy of the elevation survey is provided in Figure 2.

Figure 2. Relative differential elevation survey of site in Irving, Texas.

Based on the survey, the maximum differential elevation from the high to the low point of the floor slab was on the order of 16 inches (41cm), measured from the center of the warehouse slab to the high point at the west end of the building. The pattern of movement is consistent with the wetting front moving from the building exterior to the interior. The pattern of movement is not consistent with the presence of natural ground water.

The pattern indicated by the elevation survey is also consistent with some differential movement of the piers supporting the tilt-wall panels. Based on the observed pattern of movement, it is estimated that the underreamed piers have moved two to seven inches differentially since construction, dependent upon location. It appears the area of greatest pier movement is at the west end of the building. Movement is attributed to heave of the severely weathered shale below the founding depth of the piers.

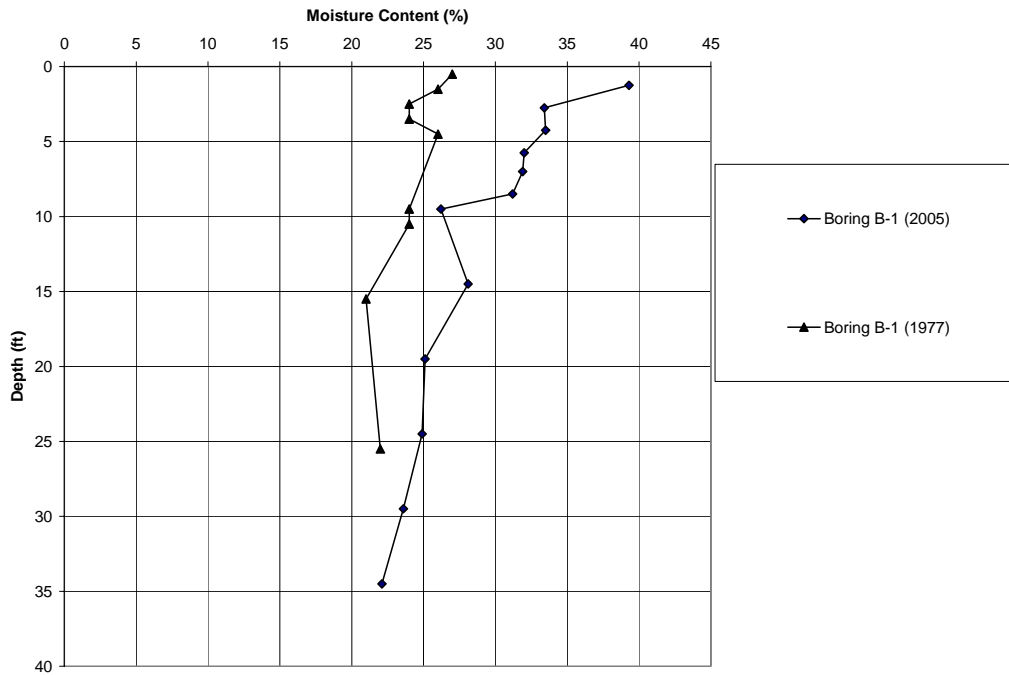
As the severely weathered shale heaves, there would be a corresponding increase in the soil moisture. A comparison of the moisture contents of the severely weathered shale, prior to construction of the building in 1977 and in 2005 at the northwest corner of the building, is presented in Figure 3.

The comparison shown in Figure 3 indicates a significant increase in moisture within the severely weathered shale during the life of the structure.

**Figure 3. Moisture Content Profile – Northwest Corner of Building.
(1 ft. = 30.48 cm)**

A comparison of the two moisture content profiles in Figure 3 indicates a significant increase in moisture since project construction. Local experience in the Eagle Ford Group indicates an approximate one percent vertical swell for each one percent gain in moisture. Using this correlation and the two moisture profiles shown in Figure 3, discounting the upper 1½ feet (.5m), an estimate of heave of 17¾ inches (45cm) is obtained. This correlation would indicate that approximately 10½ inches (27cm) of heave would be anticipated within the upper 15 feet (4.6m), with a balance of approximately 7¼ inches (18cm) of heave occurring below a depth of 15 feet (4.6m). Considering the relative accuracy of the available information, the correlation between moisture gain and observed differential elevation of both the floor and tilt-wall panels is reasonable.

This study clearly indicates a lack of appreciation for heave-related movement below what was at the time considered the active zone. Placement of a clayey sand “select” fill below grade also created a “bird bath” condition where the interface of the select fill/native soils was approximately 2½ feet (.8m) below exterior grade. Water made available along the perimeter of the structure was able to pond within the select fill and saturate the weathered shale from the top down.
