ALTERNATIVE EXPLANATION OF "LIME-INDUCED HEAVE"

Ronald F. Reed, P.E., M.ASCE

This paper reviews lime/sulfate-induced heave and documents conditions observed on differential heave of a pavement subgrade within the City of Midlothian, which is located south of Dallas, Texas. An alternative hypothesis for the observed movement is presented.

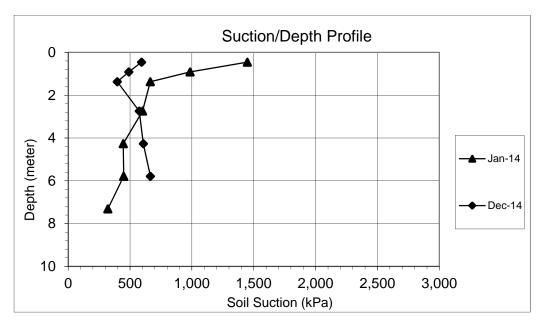
Based on extensive experience and the suction profiles shown in Figure 1, the upper soils are considered to be seasonally active to depths varying from approximately 2 m to 3 m, dependent upon prevailing weather. Identification of the seasonal activity was used to calculate the potential for movement as discussed later.

Figure 1. Total Suction Versus Depth. Tests conducted in accordance with ASTM D 5298.

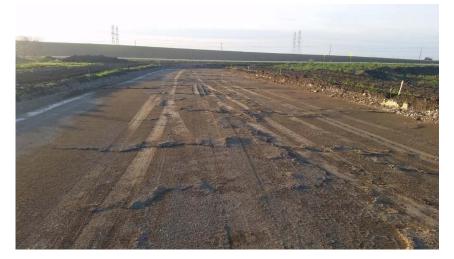
As seen in Figure 2, multiple transverse "ridges" and one longitudinal "ridge" were noted in the subgrade. The longitudinal ridge generally followed the approximate center line of the roadway. The transverse ridges were on approximate 4.6 m to 7.6 m centers. Height of the ridges varied generally from 5 to 8 cm up to a maximum of 20 cm.

An elevation survey performed after the ridges developed found that, in the relatively smooth areas, the surface had risen 2.54 to 5.08 cm above original grade. Density tests indicated, in the relatively smooth areas, no loss of density or gain in moisture.

Figure 2 illustrates the observed subgrade condition on approximately March 14, 2016.

Figure 2. Photo of general failed condition, Challenger Drive.

To limit delay of construction, the contractor was instructed to blade the subgrade to required elevation then compact with a smooth-tired roller. Field density tests were performed on March 23, 2016 to confirm that a minimum of 95% of ASTM D 698 density had been achieved. Test results are provided in Table 9.

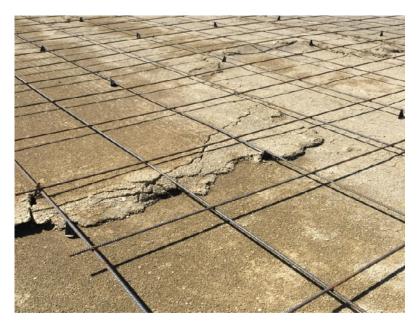
Close inspection of the ridges indicated that the limed subgrade appears to have failed in shear, as shown in Figure 3 and did not exhibit a typical pattern of heave, which would be anticipated to be more lens-shaped (high point, tapering towards the edge). In addition, both Mitchell (1986) and Hunter (1988) described heave areas where ettringite formed as moist and soft because of loss of compaction or density.

Figure 3. Close-up of shear failure. Note IPhone below reinforcing at left for relative size.

Alternatively, the behavior can be explained if the natural subgrade heaved after the lime stabilization process was completed, and the observed failures are associated with lateral expansion and closure of shrinkage cracks. Because of the rigidity of the limed layer, the horizontal pressure results in shear, with one portion of the limed layer sliding over the adjacent limed material. This type of failure hypothesis also accounts for the lack of reduction in strength or density in the undisturbed material between the ridges.

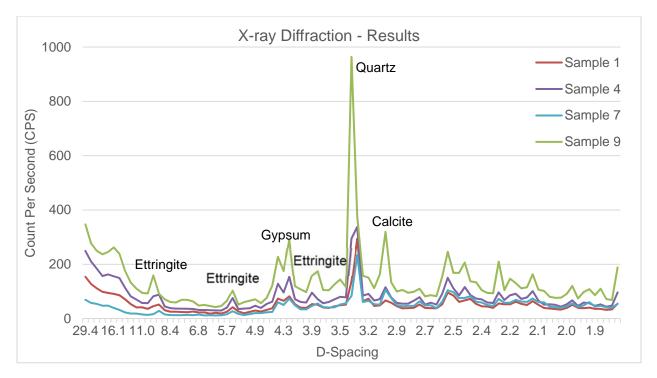
Two samples were submitted from heaved ridges and two from the relatively undisturbed area. Test results are provided in Figure 4. XRD results indicated ettringite was present at less than 200 counts per second (cps). Based on Dr. Basu's interpretation, quantities of ettringite present were limited.

Figure 4. X-Ray Diffraction Results.

Post-failure XRD analysis did not detect the presence of significant amounts of ettringite in samples from either the ridges or the undisturbed plates. Because of the limited scope, it is possible that expansive hydrates were present and not detected; however, the physical condition of the postheave subgrade would not appear to support the classical description of the lime-induced heave.

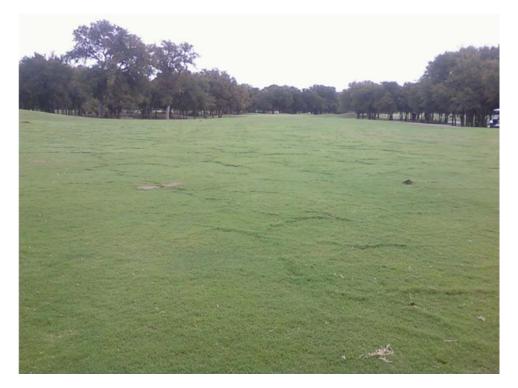
This similar appearing phenomena was noted at a golf course in Carrollton, Texas located northwest of Dallas. Relatively dry weather in the Summer and Fall of 2015 resulted in development of shrinkage cracks in an expansive clay. The golf course watered sufficiently to allow the grass to grow across the shrinkage cracks. Following heavy rainfall over an approximate 24-hour period, conditions shown in Figure 5 were noted prior to maintenance crews mowing the fairways. Close inspection of the "wrinkled" Bermuda grass noted partially closed shrinkage

cracks under the grass at each of the ridges inspected. It is interesting to note the similarity between conditions shown in Figure 5 versus Figure 2.

Figure 5. "Wrinkles" within fairway grass associated with closure of shrinkage cracks in underlying soils.
