IS IT TIME TO GET THE CITIES INVOLVED?

ASCE SPRING MEETING  
CORPUS CHRISTI, TEXAS  
APRIL, 1994

RONALD F. REED, P.E.  
REED ENGINEERING GROUP, INC.  
2424 STUTZ DRIVE, SUITE 400  
DALLAS, TEXAS 75235  
TELEPHONE: (214) 350-5600  
FACSIMILE: (214) 350-0019

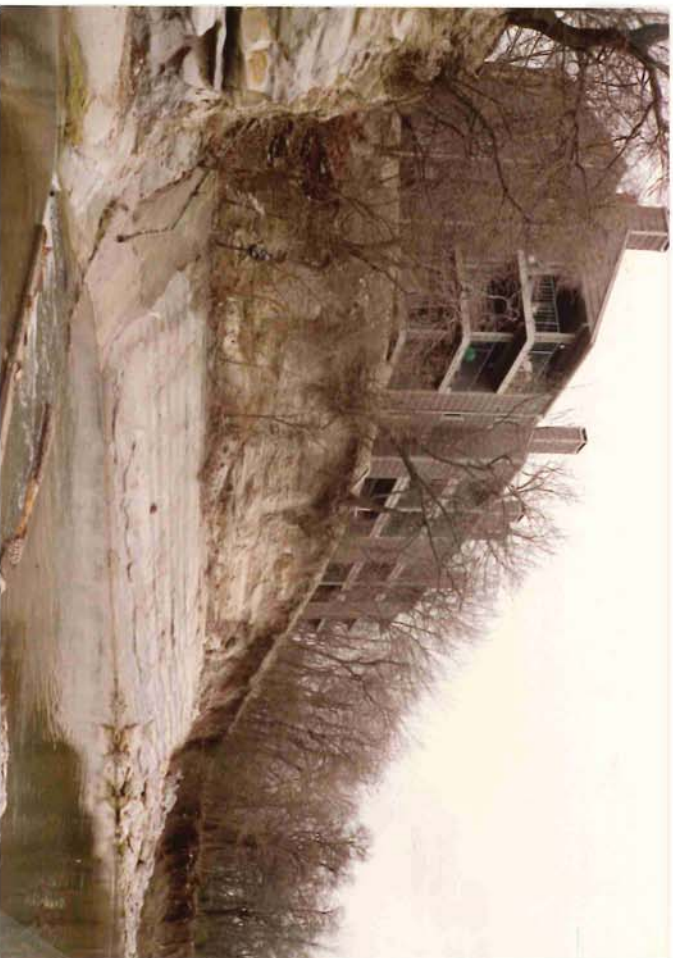
An example of the type of geologic processes and loss, which are the subject of this paper, is shown in Photograph 1. Erosion of the stream bank resulted in continued undermining of a building foundation. To protect the apartment building from further undermining, a thin section gabion wall with rock anchors was designed and constructed at a cost of \$300,000. The completed section is shown in Photograph 2.

Photograph 1. Erosion and steepening of a cut bank within the Austin Chalk Formation. Note undermining of front corner of foundation.

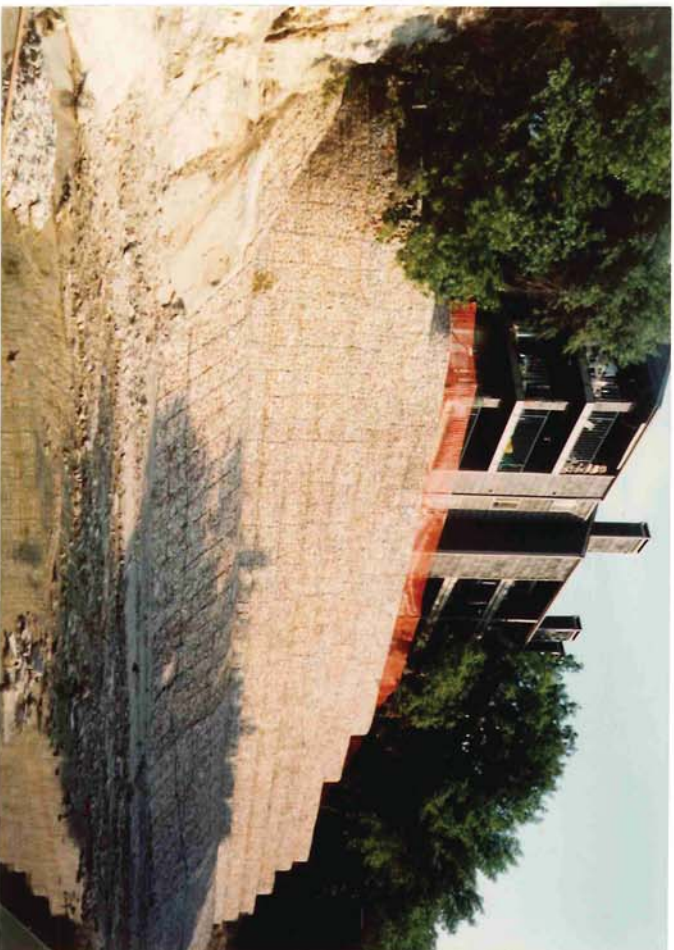
Photograph 2. Constructed thin section gabion wall with rock anchors. Construction cost \$300.000.

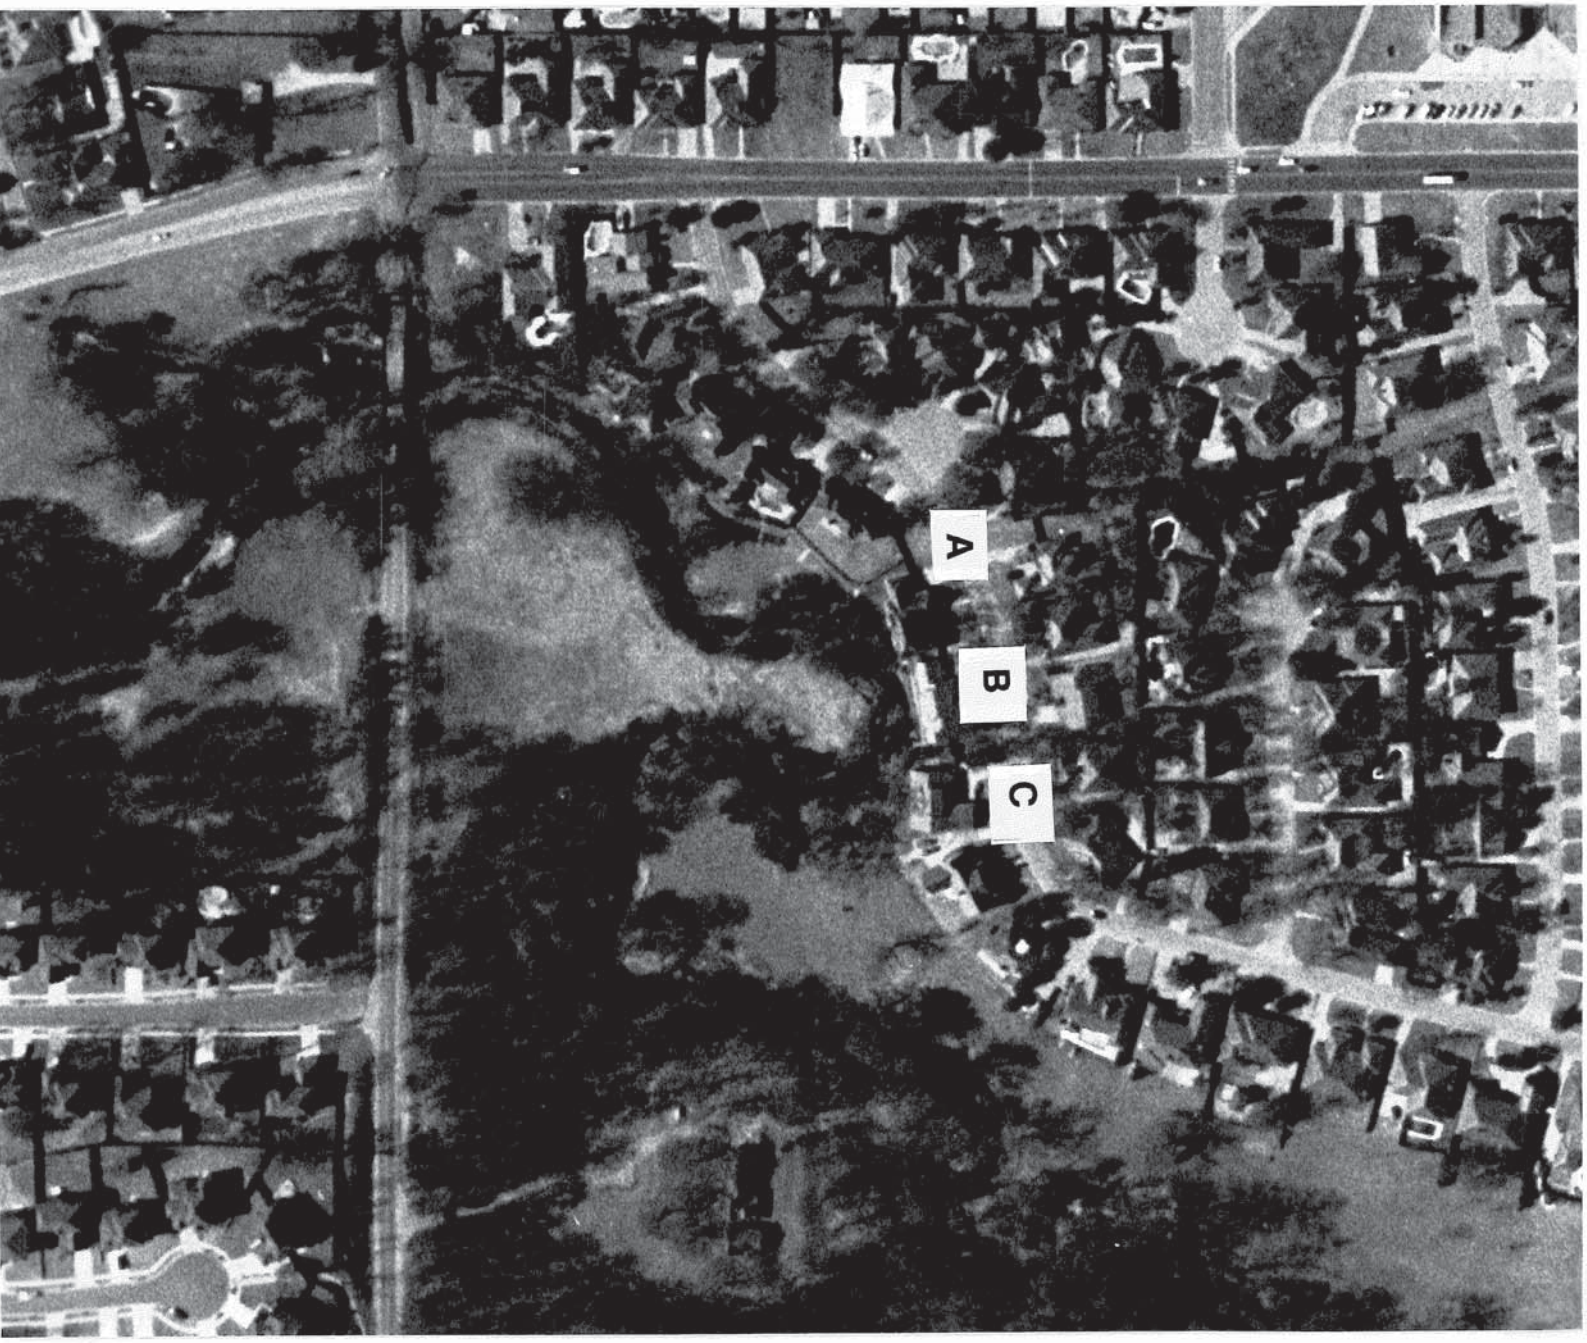
Two specific houses are at the apex of the meander bend, and suffered the worse damage. An aerial view of the study area is shown in Photograph 3. The homes in question are labeled A through C for discussion purposes. Homes A and B are currently abandoned.

Photograph 3. Aerial view of residences, case study 1 showing proximity to the creek and location of meander bend.

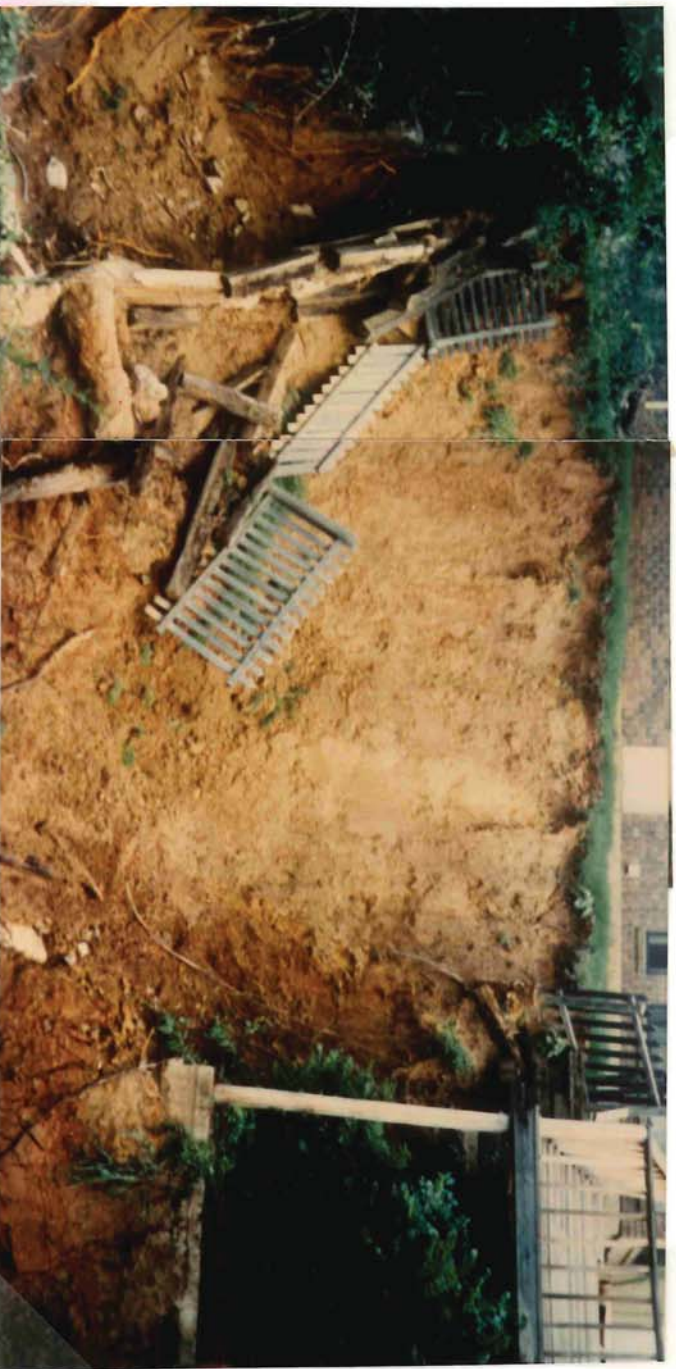
The homeowners attempted to mitigate damages associated with flood events by the use of railroad retaining walls. Home B suffered continuing erosion, with a significant flood and erosion occurring in 1989 which resulted in undermining of the foundation. Conditions after the 1989 event are shown in Photograph 4.

Photograph 4. Composite photograph of conditions at Residence B after 1989 flood event.

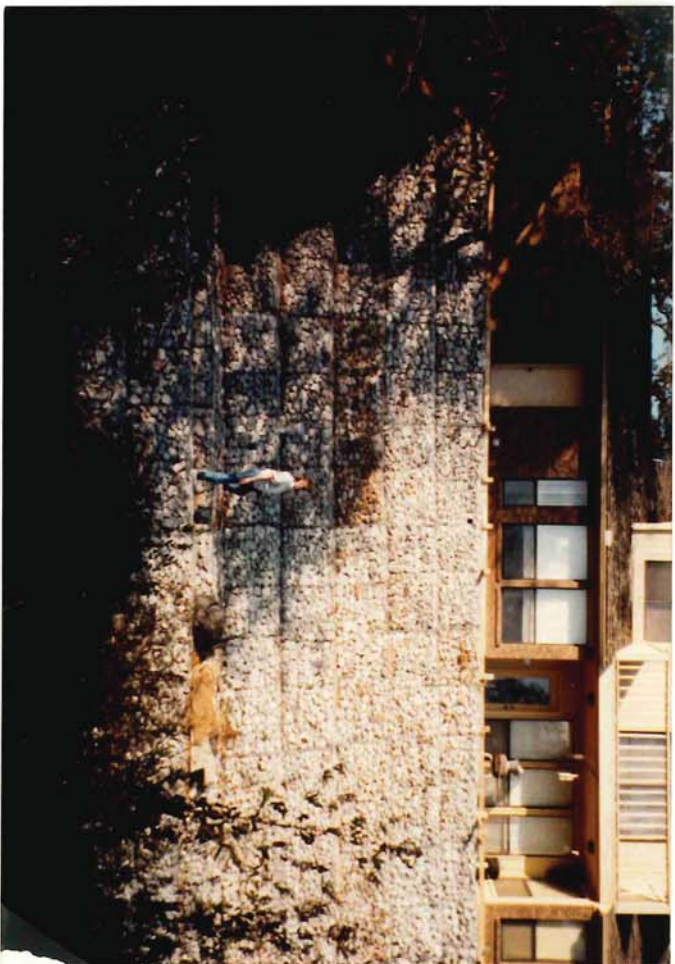
Photograph 5. Completed gabion section prior to November 1991 flood.

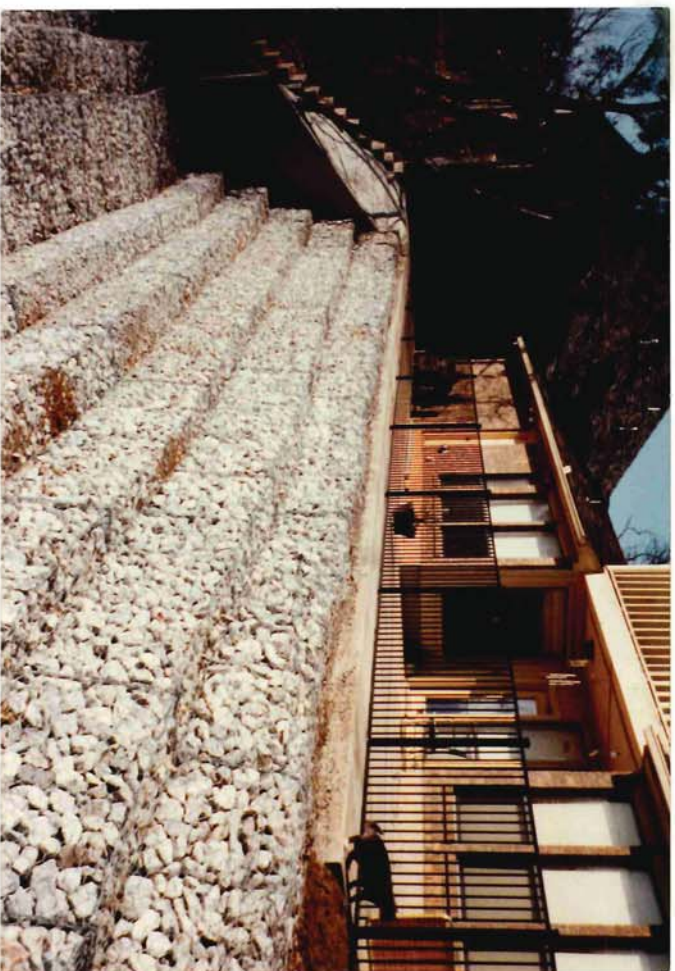
Photograph 6. Completed gabion section prior to 1991 flood. Camera pointed west towards residential Lot A.

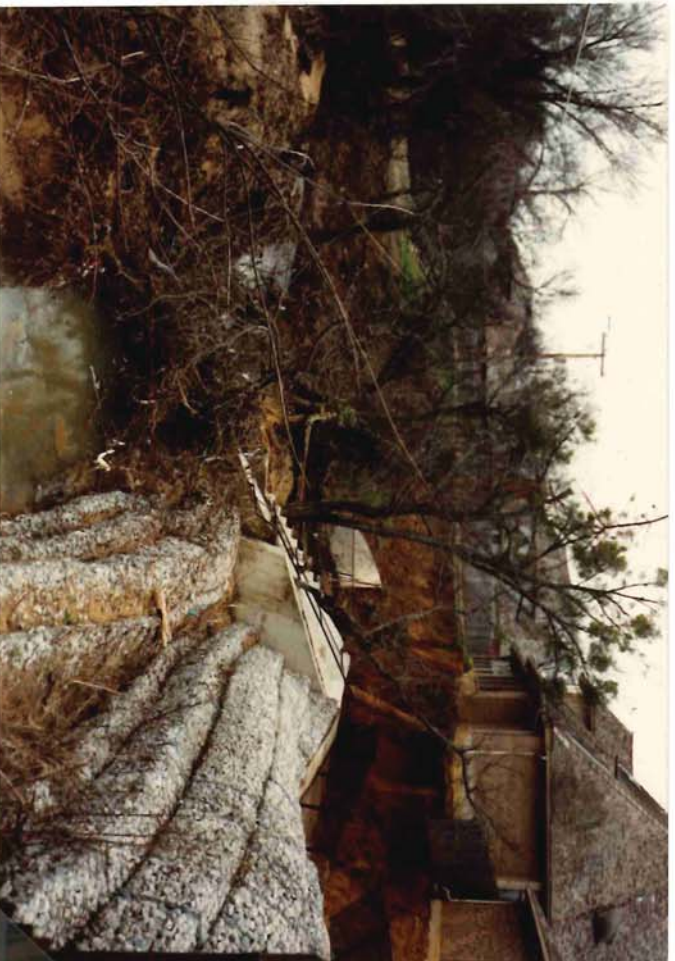
Following extreme flooding events in November 1991, the west end of the gabion wall system failed as a result of a deep slide centered on the upstream lot (Lot A). The condition of the wall and foundations on Lots A and B are shown in Photographs 7 through 9.

Photograph 7. Condition of gabion wall after November 1991 flood. Camera pointed west. Residence on Lot A is located in the upper right corner of the photograph.

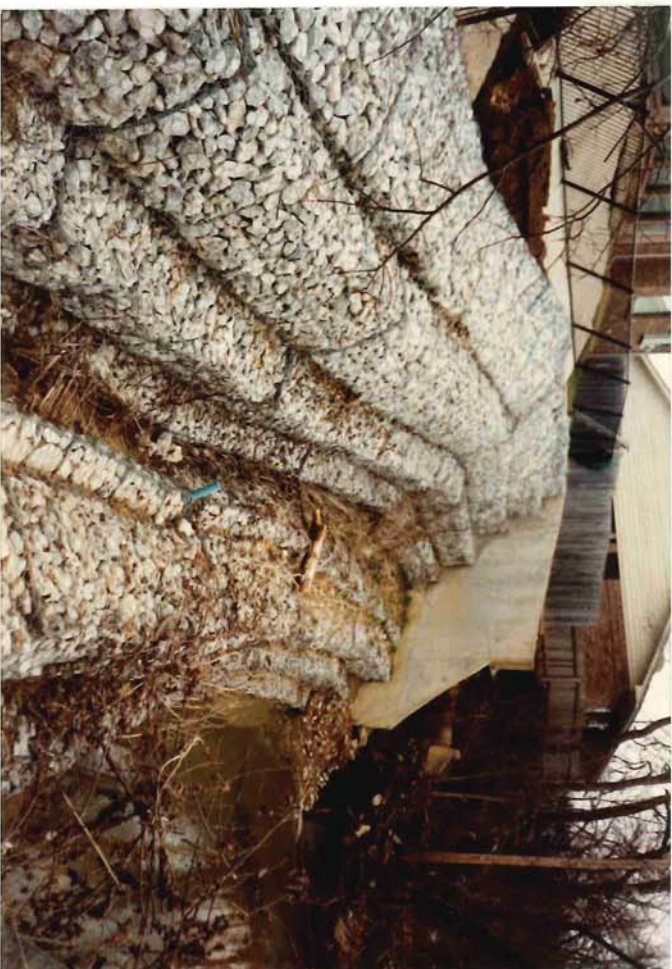
Photograph 8. Condition of east end of gabion wall after 1991 flood.

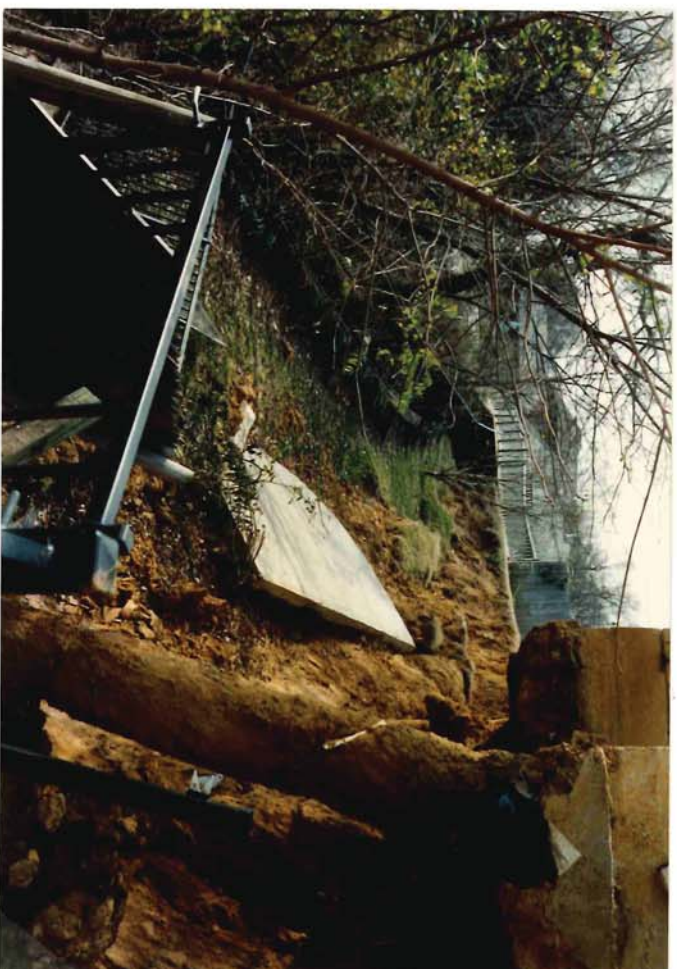
Photograph 9. Head scarp on Lot A. Portion of foundation on Lot A is visible on the right side of photograph.

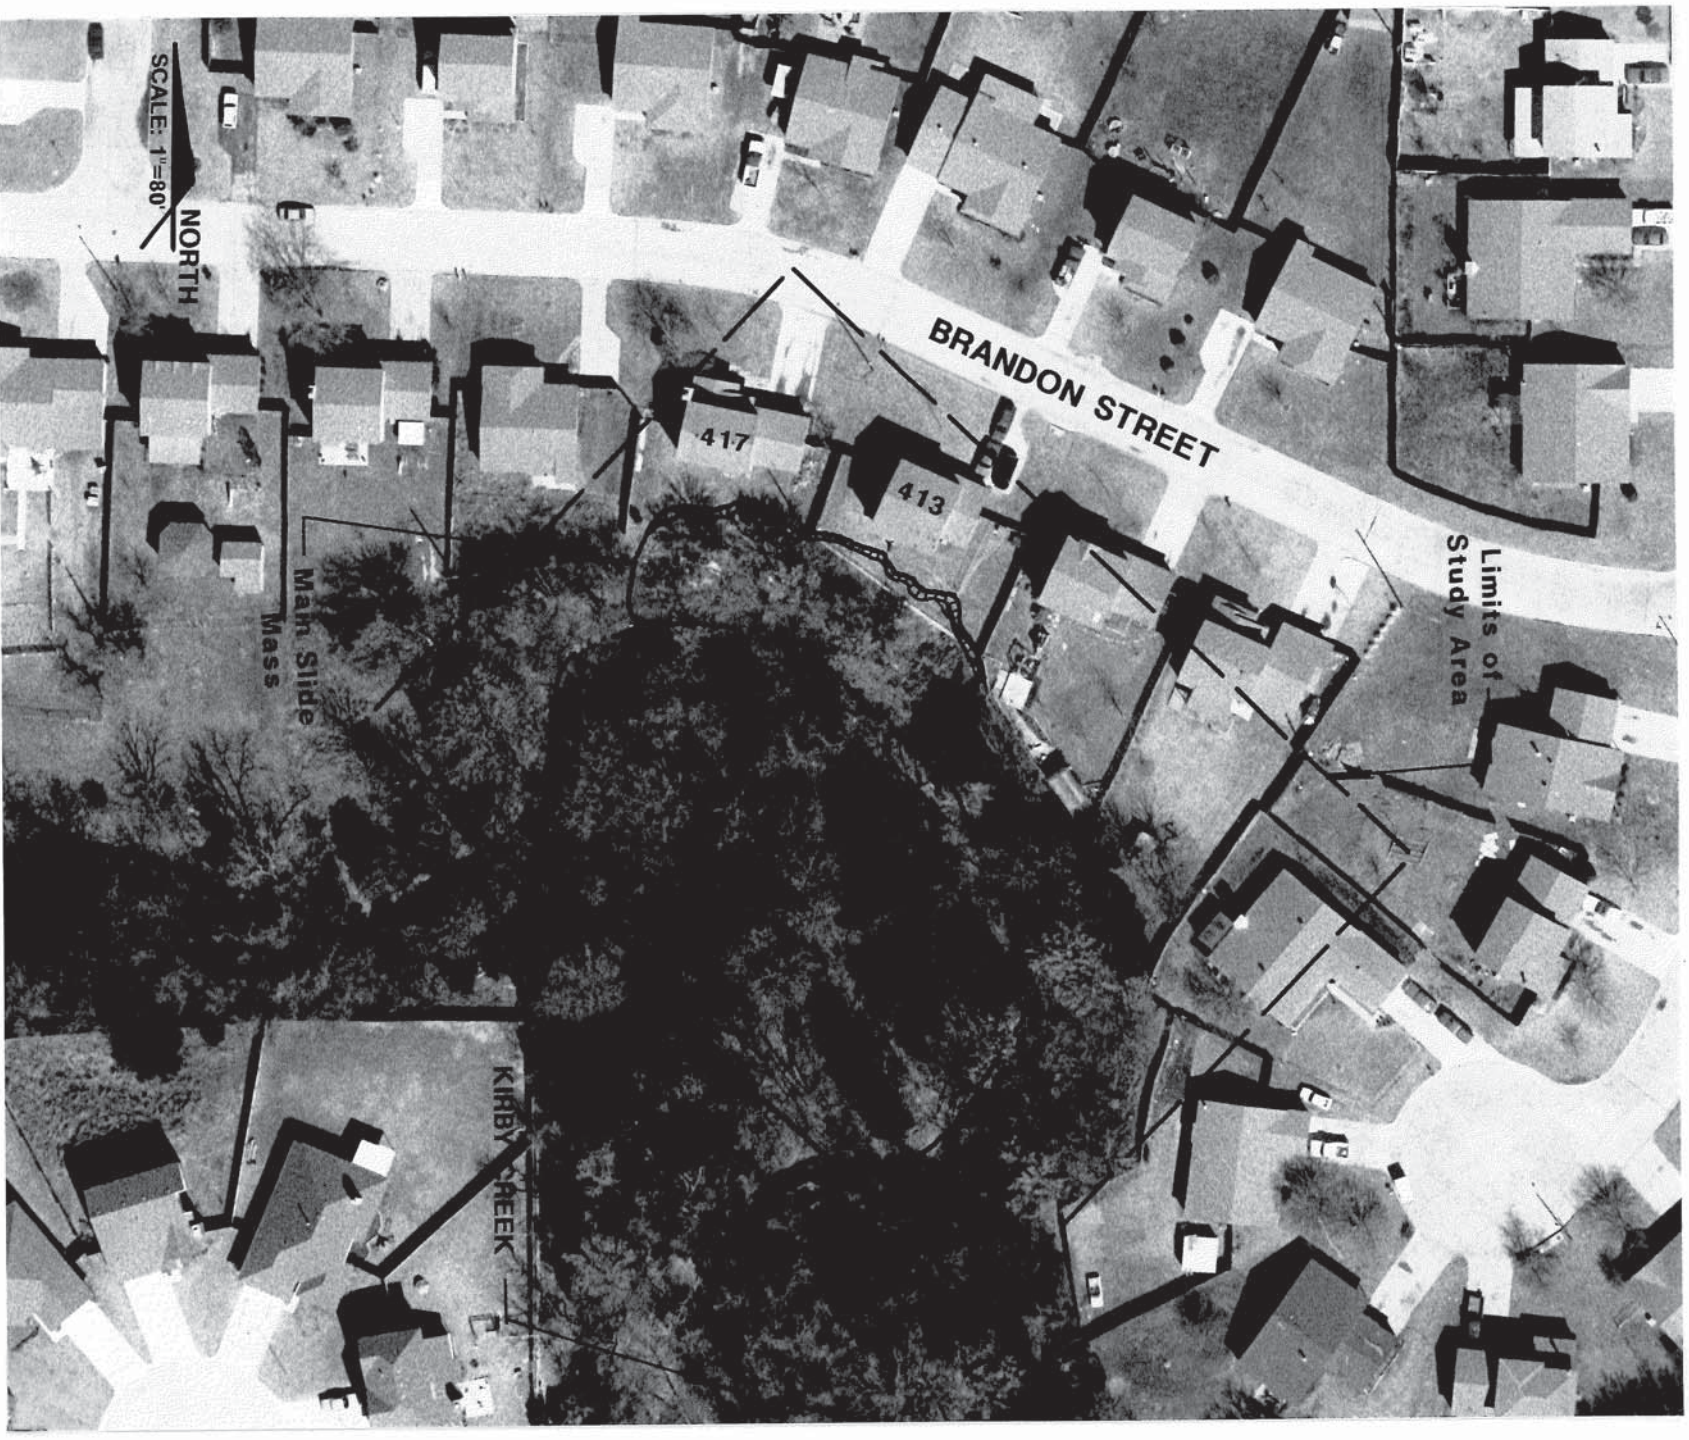
Photograph 10. Aerial view of residences and creek prior to slope failure. Note proximity of rear yards to creek bank.

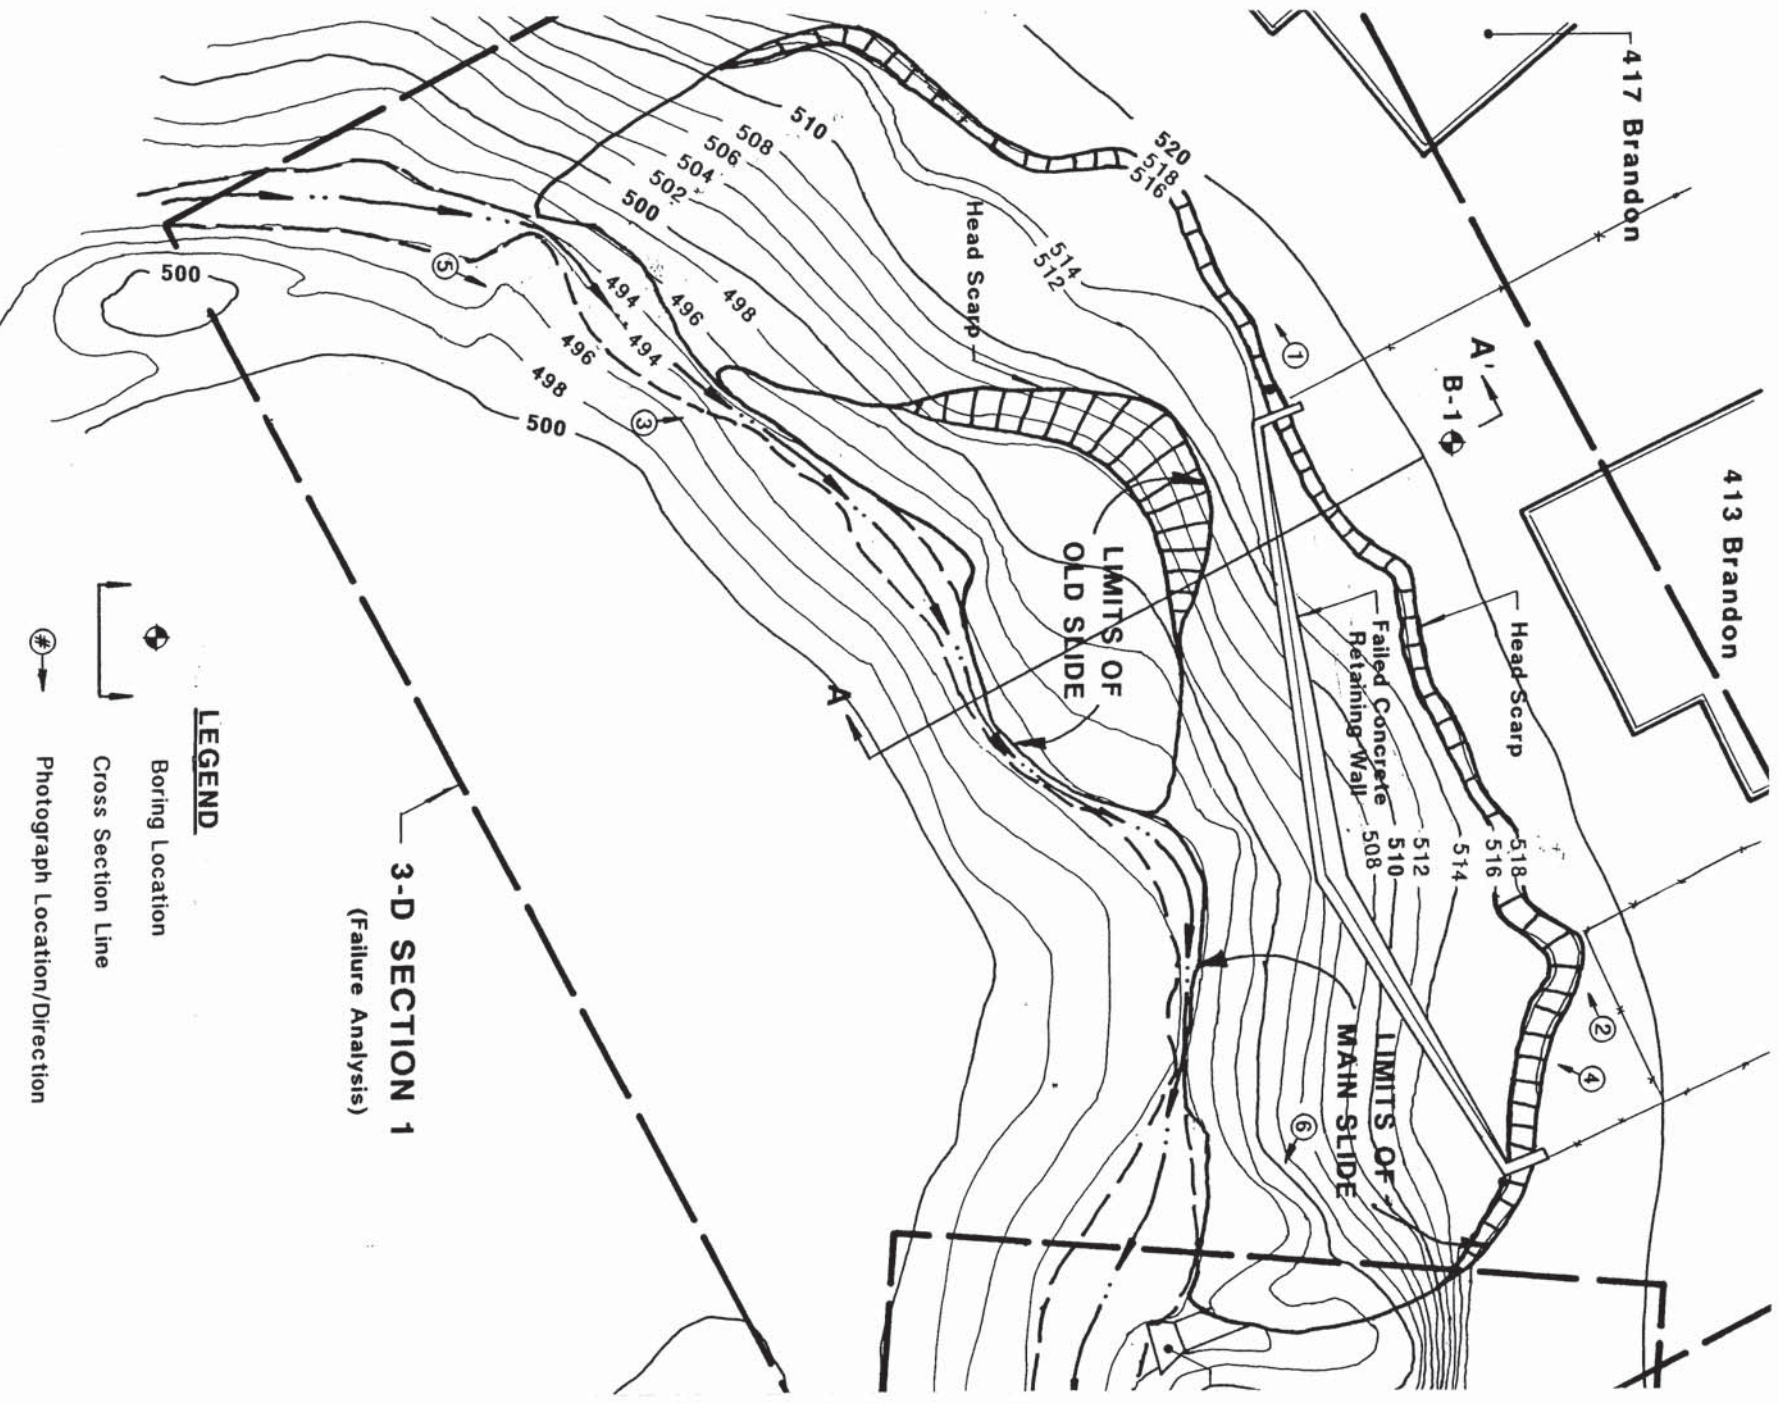
Figure 3. Topographic survey of slide area. Case Study 3.

The slope failure encompassed approximately 160 linear feet of stream bank, comprising three residential lots. An aerial photograph and topographic survey of the conditions are shown in Photograph 10 and Figure 3, respectively. Conditions shortly after failure are shown in Photographs 11 and 12.

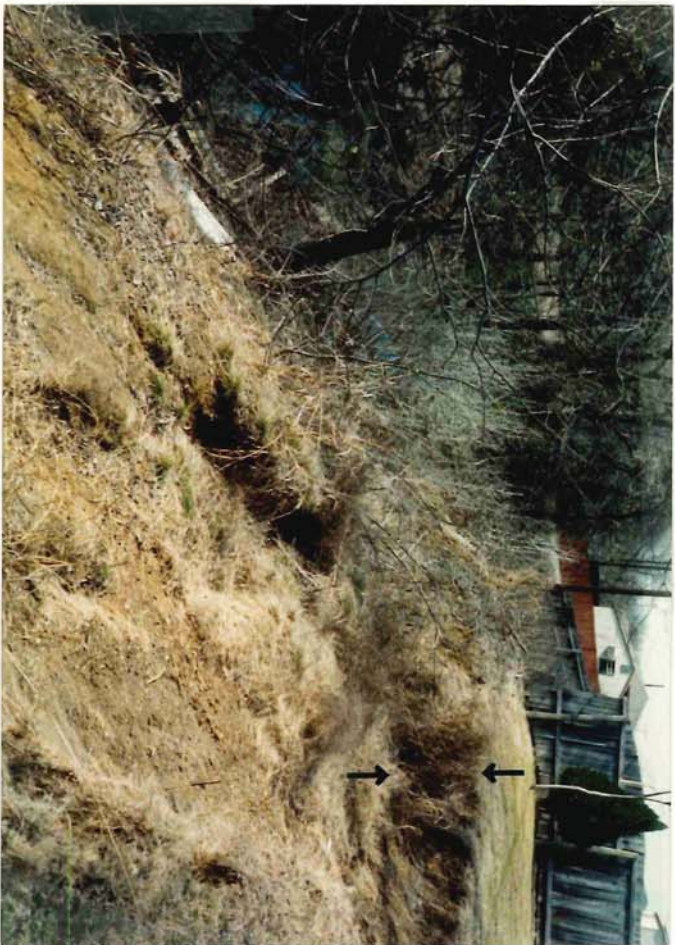
Photograph 11. Head scarp at 417 Brandon Street.

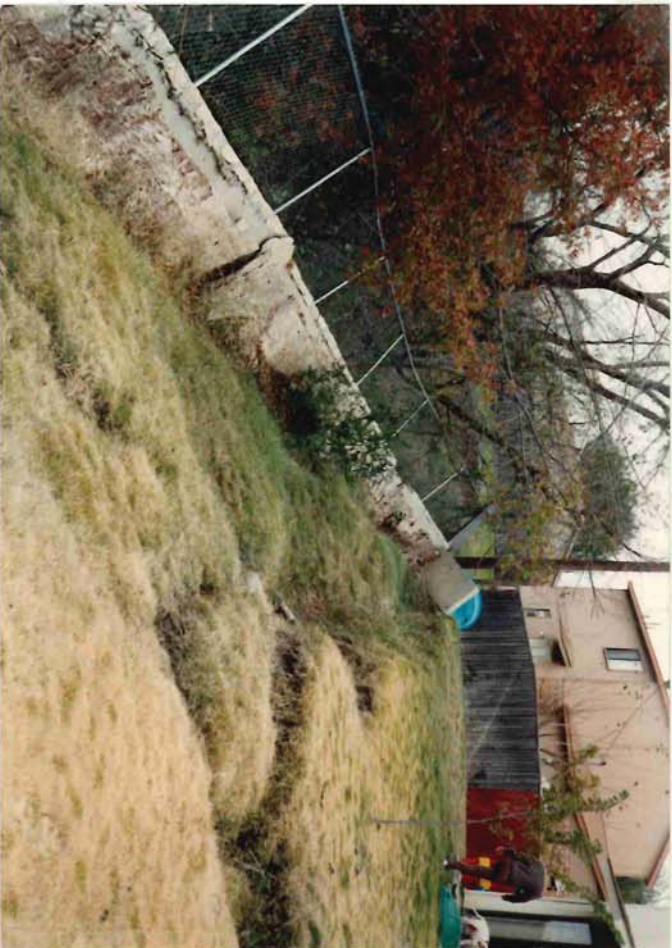
Photograph 12. Head scarp of slope failure at 413 Brandon Street.

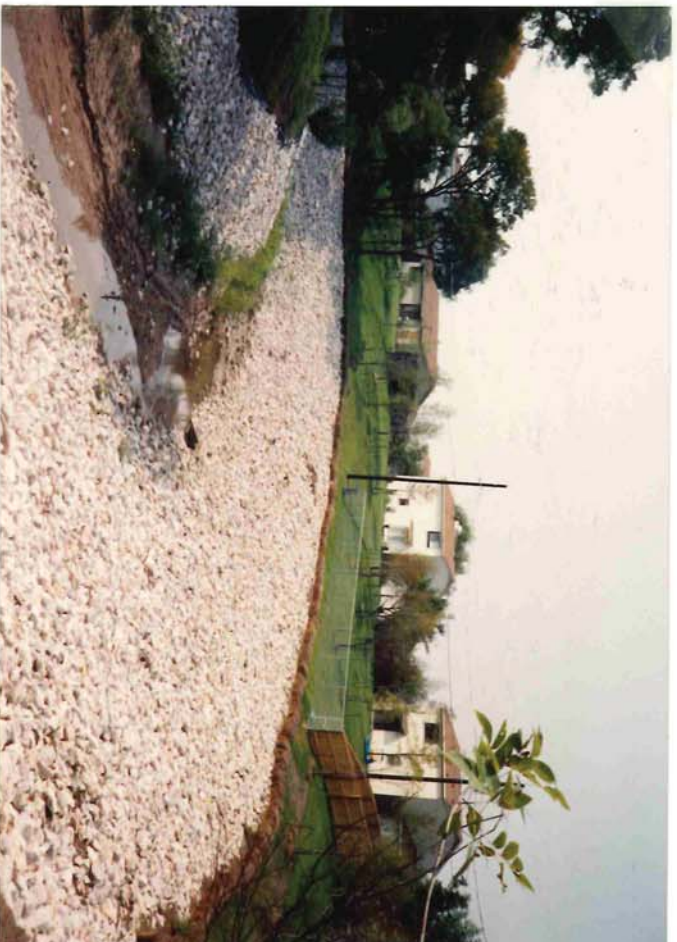
Photograph 13. Completed section of re-graded creek and armored slope. Residences at 417 and 413 Brandon Street in the middle and right of photograph.

Numerous solutions were evaluated, with the chosen repair consisting of slope reconstruction, flattening and use of rock rip-rap for slope armor. This alternative incorporated relocation of the creek channel. Engineering services and construction costs were paid for by the municipality. The total cost of reconstruction was \$398,000. The completed section is shown in Photograph 13.
