IS IT TIME TO GET THE CITIES INVOLVED?

ASCE SPRING MEETING  
CORPUS CHRISTI, TEXAS  
APRIL, 1994

RONALD F. REED, P.E.  
REED ENGINEERING GROUP, INC.  
2424 STUTZ DRIVE, SUITE 400  
DALLAS, TEXAS 75235  
TELEPHONE: (214) 350-5600  
FACSIMILE: (214) 350-0019

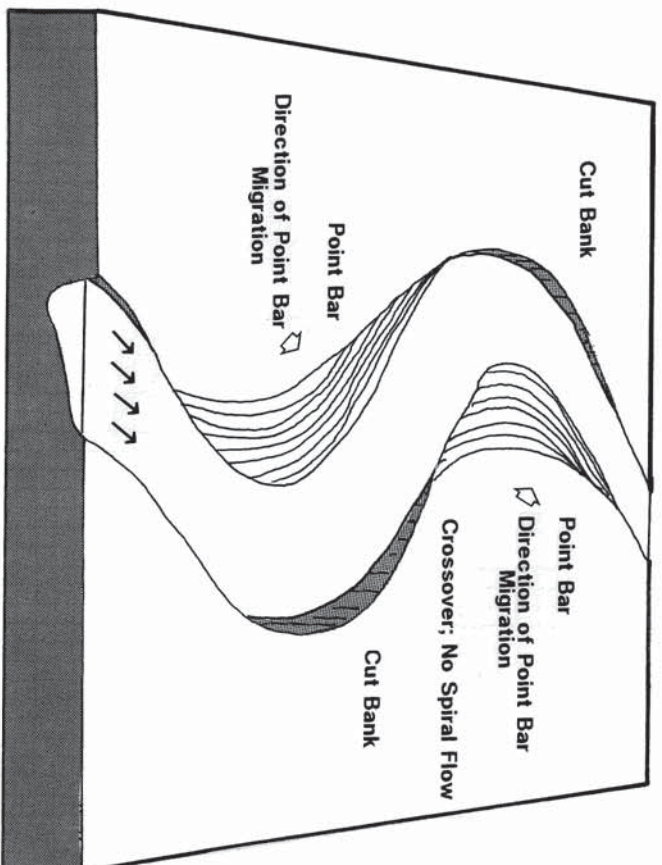
One condition in particular which results in failure frequently reoccurs; development of property on the cut bank side of creeks and streams. The cut bank side of a creek is the outside edge of a meander bend. An idealized meandering stream with identified cut banks is shown in Figure 1.

Figure 1. Meandering stream with cut banks.

The outside edge of the stream meander is subject to deepening and lateral erosion. The magnitude and time rate of erosion is dependent upon stream velocity and the geologic setting. These processes are hastened by high stream flow and are therefore time (or weather) dependent.

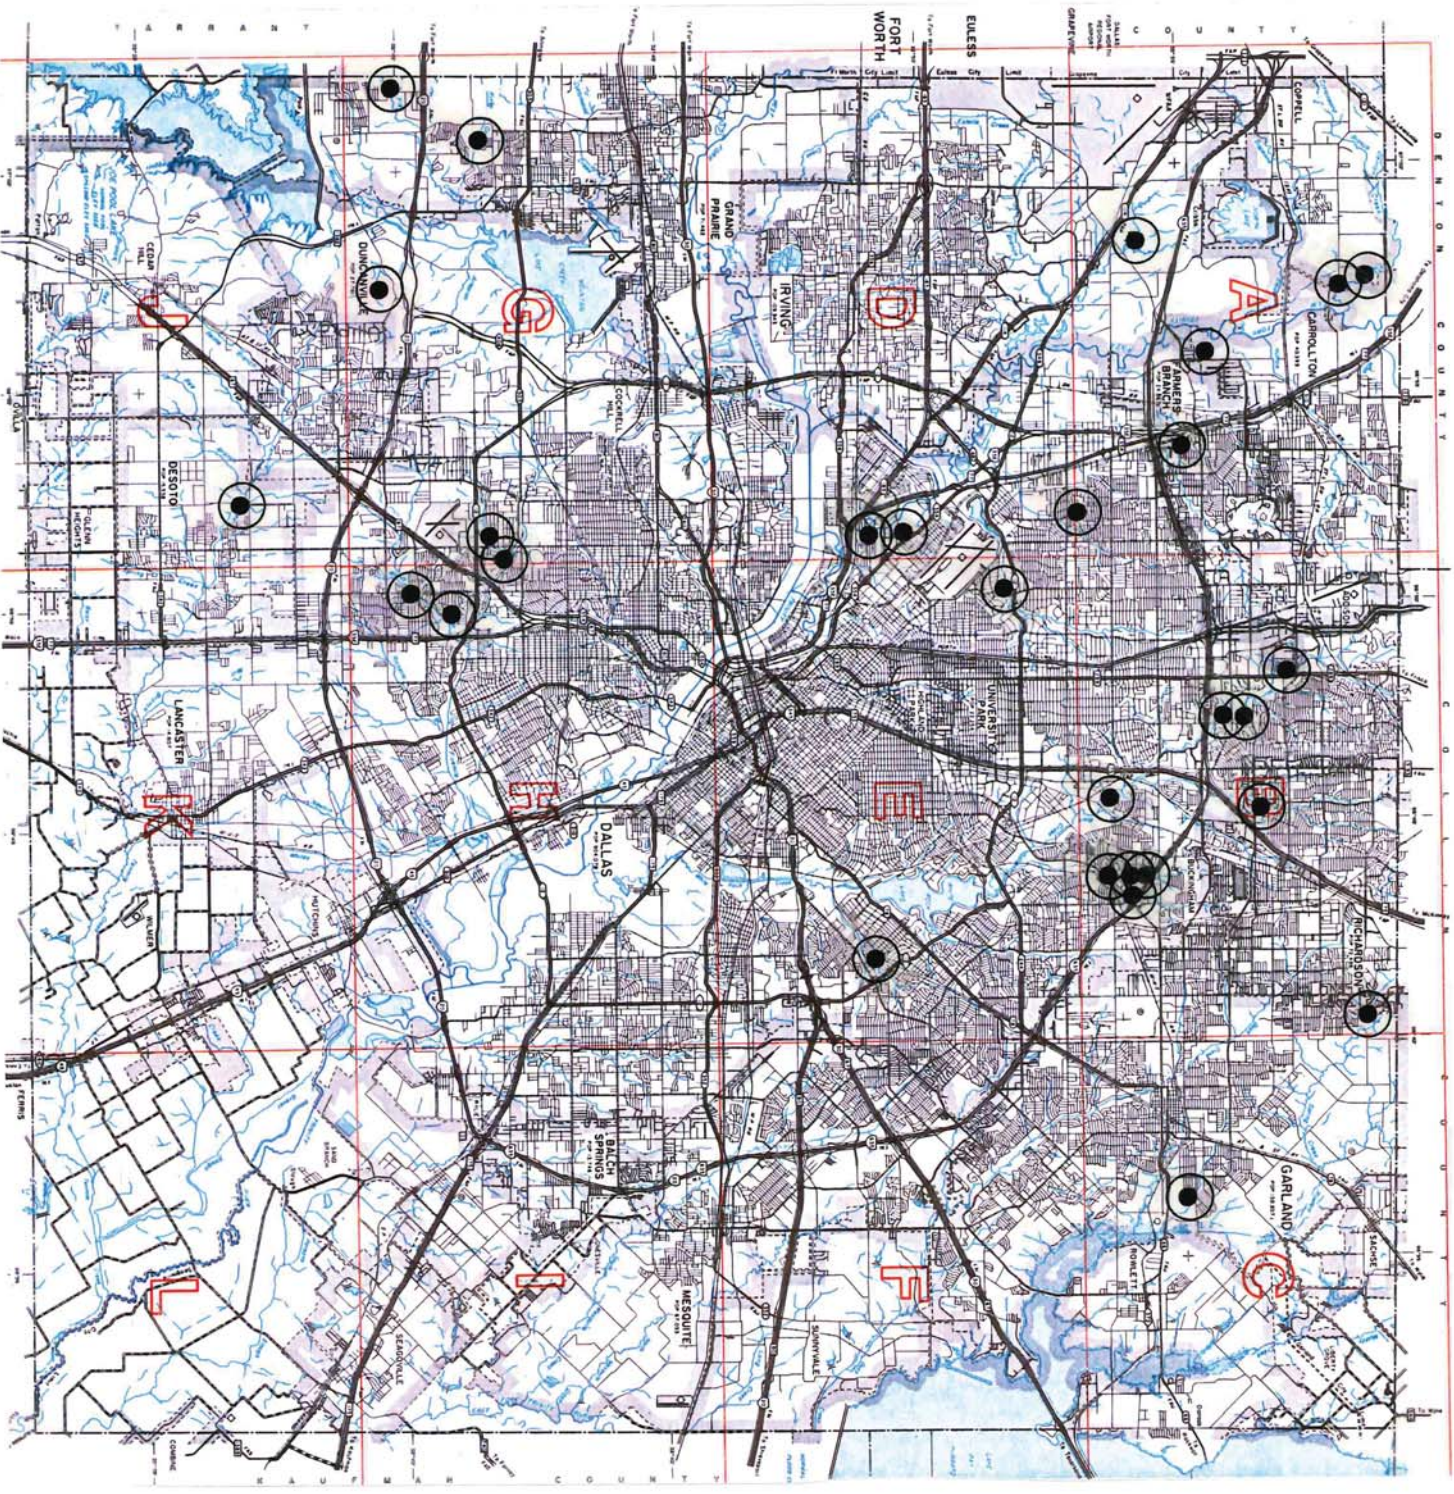
Figure 2 illustrates locations of various erosion projects on cut banks within Dallas County. A partial listing of various projects with their associated repair costs within the greater Dallas/Fort Worth metropolis is provided in Table 1.

Figure 2. Location of stream erosion studies at cut banks. Dallas County.
